**Independent Investigation of the Catalyst
Release from Martinez Refining Company on
November 24-25, 2022**

Report prepared by
Scott Berger and Associates, LLC

Version 2
March 27, 2024

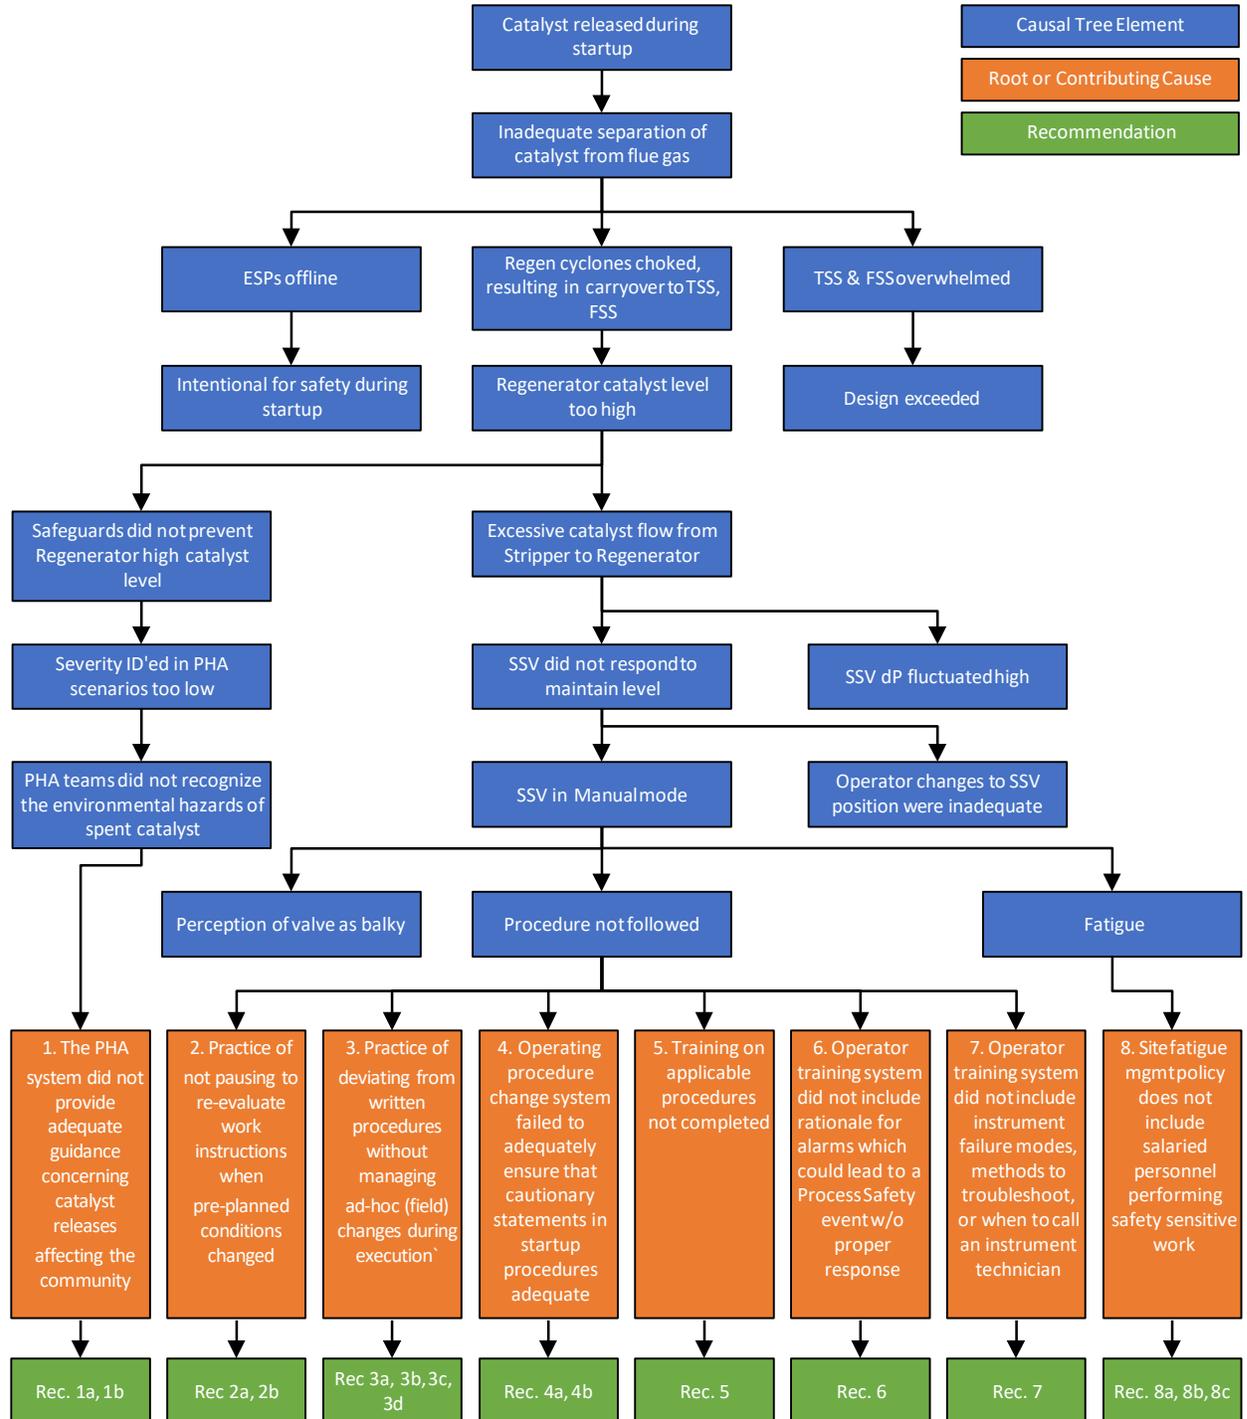
Figure 2: Causal tree of November 24-25, 2022, Catalyst Release Incident

The causal tree for this incident is shown below (Figure 2). The key links in the causal chain are described in this section.

Evaluation of PHA scenarios as “No Action Required”: Long before this incident, two separate process hazards analyses (PHAs) had been conducted. Each considered causes that could lead to catalyst carryover: the Shell Oil Products CCU PHA in 2018, and the MRC/PBF CO Boilers PHA in 2022. Each PHA team identified scenarios with a potential for a severity two (2) environmental consequence (meaning, minor or no lasting environmental effect, a quantity of release requiring agency notification, or short duration remediation). After evaluating the 2022 catalyst release, CCHHMP determined that the event was a Community Warning System (CWS) Level 2 or higher MCAR due to the need to clean up the released catalyst. The Shell and MRC/PBF systems assign a consequence category of 3 if environmental cleanup is required.

The failure to ensure the SSV was in Auto before introducing feed is a deviation from procedures that had a direct causal link to the incident. Several other deviations from procedures (discussed in section VI.C) served as distractions to personnel and therefore contributed to the incident.
