**RE: Second 30-Day Update Report: January 29, 2017 Delta Energy Center Incident**

Subject: Delta Energy Center Oil Discharge – Emergency Response Final Report

# Delta Energy Center Oil Discharge – Emergency Response Final Report

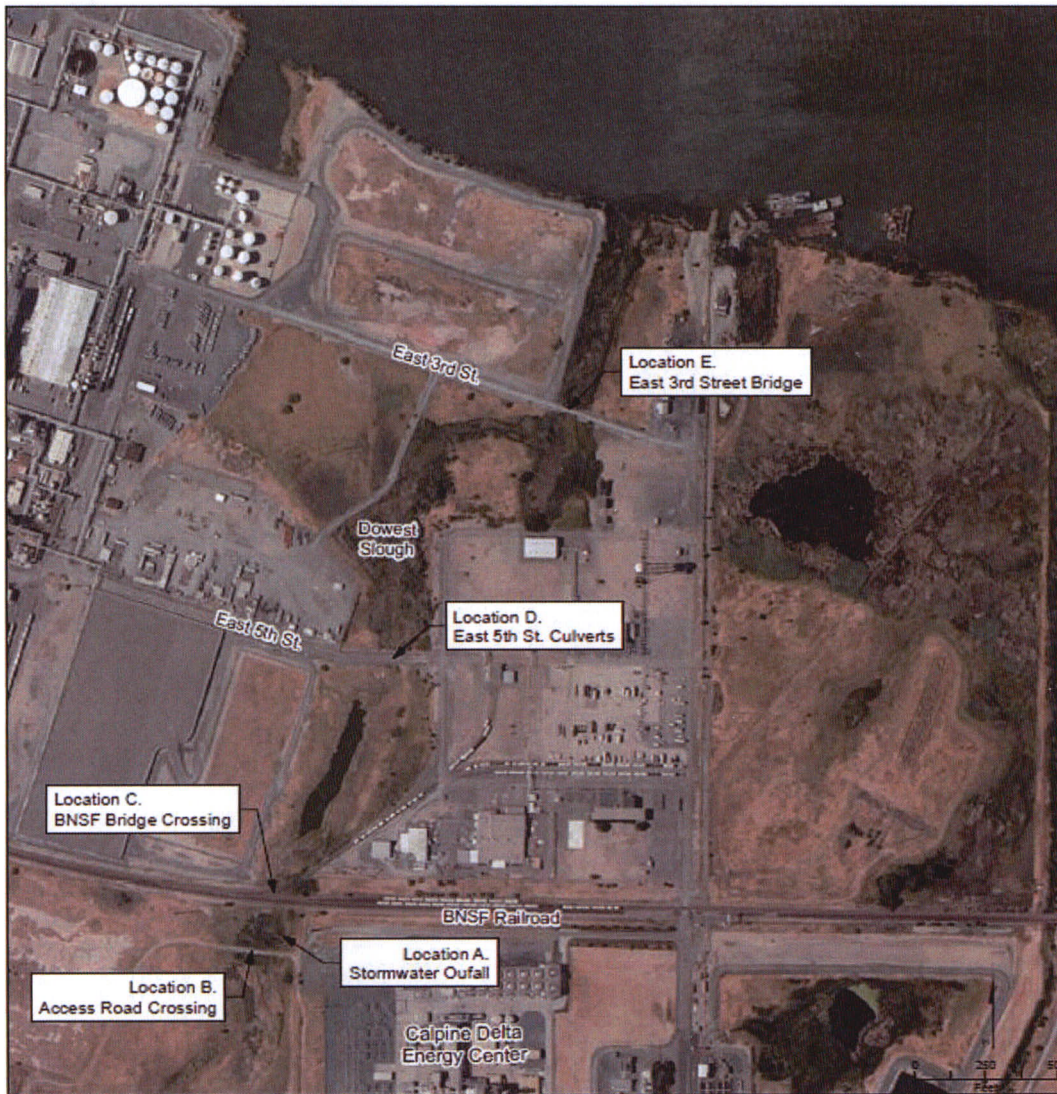
**FIGURE 1**  
**Site Figure**  
 Calpine Delta Energy Center Oil Discharge -  
 Emergency Response Closeout  
 Calpine Delta Energy Center, Pittsburg, California

- On January 29, 2017, Contra Costa Hazardous Materials Division responded to the incident, and assisted Delta Energy Center in deploying booms and pig mats in the outfall area and downstream of the outfall at Location C on Figure 1. The pig mats and absorbent booms were inspected every 2 hours and replaced with new booms, as appropriate, as they absorbed the oil.

- On January 31, 2017, oil absorbent floating booms were installed at the stormwater drain outfall to waters connected to Dowest Slough (Figure 1, Location A), the access road crossing south of the stormwater drain outfall (Figure 1, Location B), the Burlington Northern Santa Fe (BNSF) bridge crossing at the margins of the BNSF right-of-way (Figure 1 Location C), the culverts at East 5th Street (Figure 1, Location D), and the bridge at East 3rd Street (Figure 1, Location E). A vacuum truck was also deployed to the stormwater drain outfall to remove as much residual oil from the subsurface drainage system as possible. A summary of initial site observations, emergency response activities, and recommendations was presented in the *Calpine Delta Energy Center Oil Discharge - Site Observations and Response Recommendations* dated January 31, 2017. In addition, a permit application was submitted to USACE and the Water Board for the General Permit.

- On February 8, 2017, CDFW requested that an underflow dam be installed at Location C (Figure 1) to reduce potential migration of oil beyond the BNSF bridge crossing that could be caused by forecasted heavy rains.

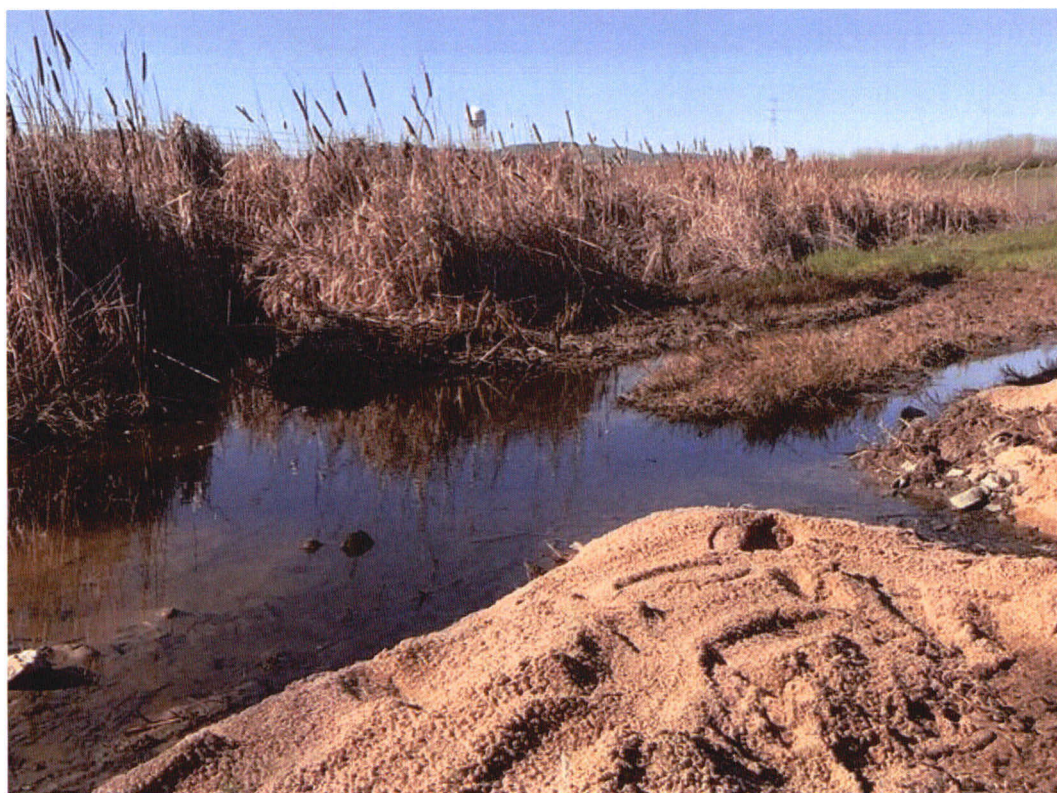
*Photograph 4. Post Boom and Dam Removal (Location B). February 28, 2017.*

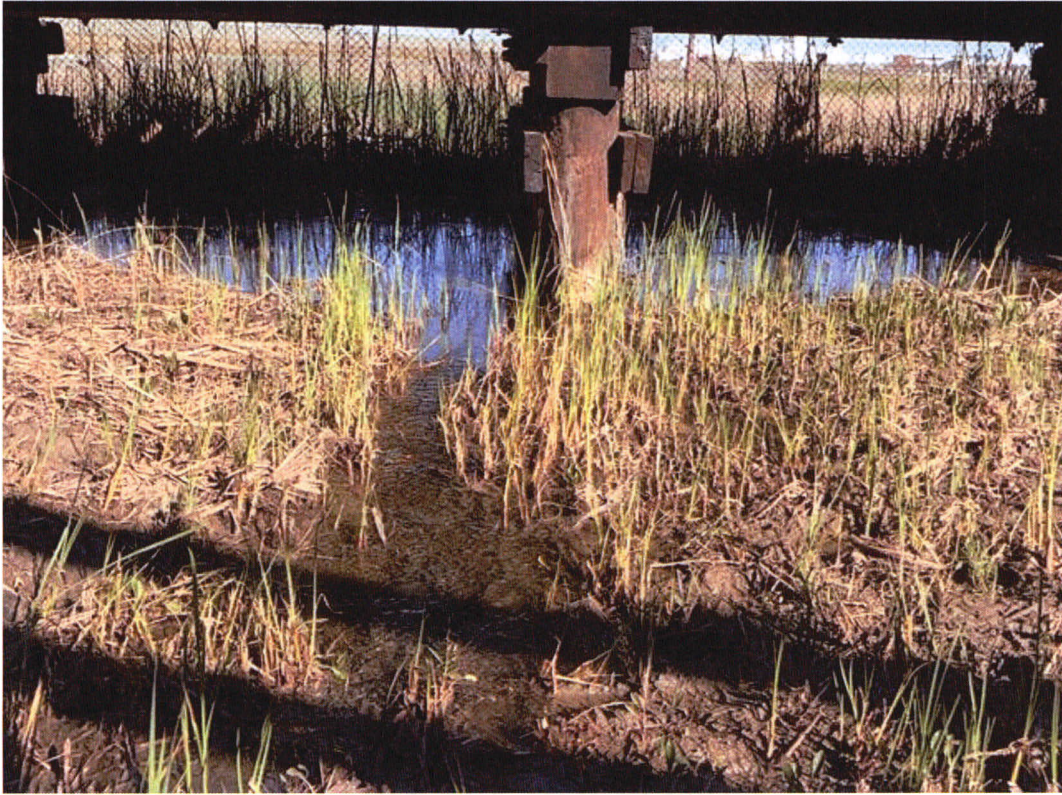
*Photograph 5. Post Boom and Dam Removal (Location C). February 28, 2017.*
