IR 16-08-13-01

Shell
Martinez
Refinery

J-168 Flaring Incident

Level 1 Technical Study

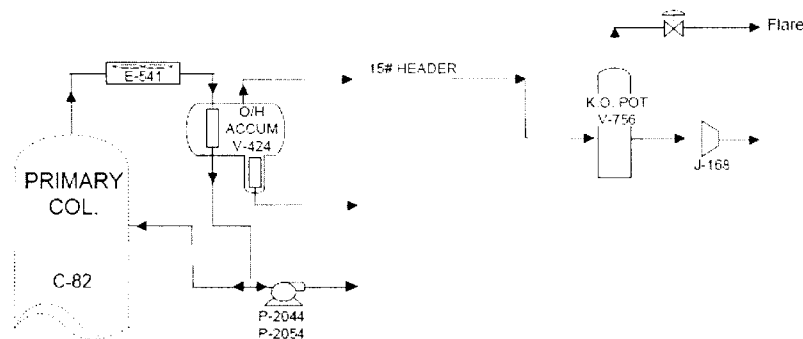
Process Flow Diagram (PFD)

The primary column (C-82) separates gasoline to diesel range hydrocarbons. The column overhead accumulator (V-424) stabilizes the column overhead liquid product by allowing vent gases to evolve to the 15# header before the liquid is pumped by overhead pumps P-2044 or P-2054 to a downstream process unit. The vent gas from the overhead accumulator is routed by the 15# header to the vent gas compressor knock-out pot (V-756) prior to being compressed through the vent gas compressor (J-168). The vent gas compressor has a controlled protective function to trip on high knock-out pot level to prevent liquid from going to the compressor. See process flow diagram below for details.

At approximately 12:21 pm J-168 tripped on a controlled protective function due to high liquid level in V-756. The increasing liquid level in the knock-out pot was caused by an overflow from the upstream overhead accumulator, V-424. The level in V-424 began to increase when overhead pump P-2054 tripped unexpectedly. At the time of the pump trip, the spare overhead pump (P-2044) was drained and blocked in due to a potential fugitive emission leak on a fitting of the seal flush tubing. After it was determined that the spare pump (P-2044) was safe to re-start, Operations started pump P-2044 and levels returned to normal.

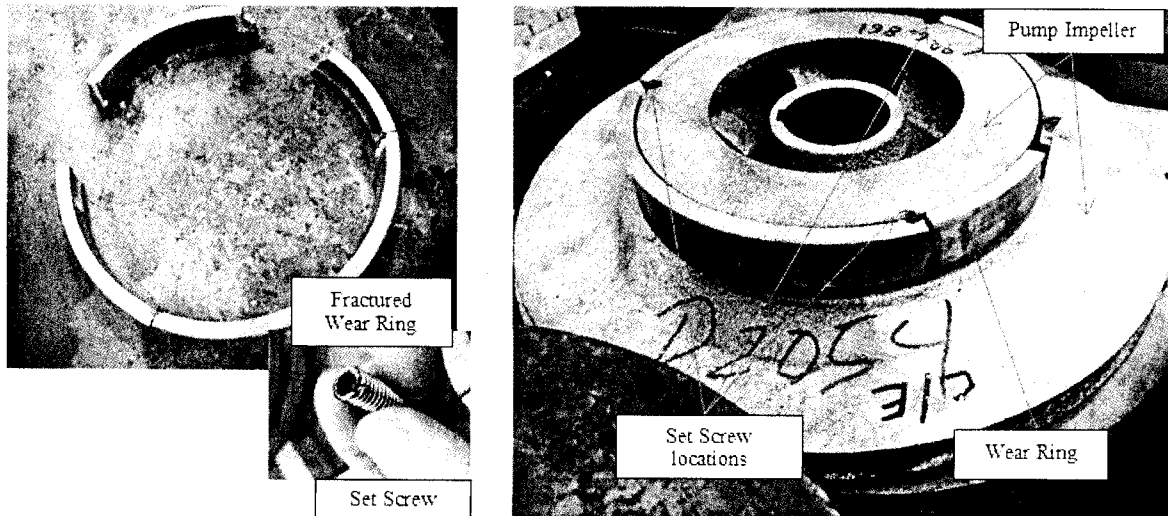
P-2054 Impeller and Fractured Wear Ring

The overhead pump (P-2054) tripped on high amps due to a resistance in the pump's forward rotation. The resistance to rotation was caused by friction between the impeller wear ring and the pump wear ring. The outer diameter of the impeller wear ring increased and touched off on the inner diameter of the pump case wear ring.

The impeller wear ring was found to be fractured at the set screw locations, as seen in the picture above. The causes of this incident were deduced basis visual inspection of the fractured wear rings, pump overhaul history and process conditions around the time of the incident.

The cause of the fracture was likely due to an existing crack in the wear ring at a set screw location. It is likely that a process temperature change caused the existing crack to propagate and the wear ring fractured Approximately 10 minutes prior to the overhead pump trip, an upstream air cooler (E-541) was actively placed online to decrease process temperature. The process temperature was decreased about 30°F and was operating within temperature limits.

The initial crack in the wear ring was likely due to the fact that the wear ring had been subject to thermal stresses over the life of the wear ring. Stress from thermal fatigue on the wear ring could be caused by pump start-up and shut-down activities or thermal fatigue could be caused by heat that was applied to the impeller, as part of common maintenance practice, for impeller removal from the shaft during pump overhauls.

The overhead pump (P-2054) was rebuilt with the existing impellers and a new shaft during the June 2016 overhaul. The pumps wear rings satisfied dimensional checks and visual inspections during the pump rebuild, and thus the pump was returned to service. Wear rings are left in place when visually inspected, however, making it difficult to identify cracks at the inner diameter of a set screw location.

Recommendation	Responsible Manager or Individual	Estimated Completion
1. Non-destructively test (NDT) P-2054 pump wear rings during inspection after incident and determine whether wear rings are to be replaced with new.	CMD Shop Inspector	COMPLETED
2. Update P-2044 "Pump Inspection Work Scope Template" to include evaluation of cast iron wear rings for non-destructive testing or replacement with new	CMD Shop Inspector	3/30/2017
3. Update Mechanical Equipment Guidelines - 020 "Wear Rings in Centrifugal Pumps" to include verbiage regarding evaluation of cast iron set-screwed wear rings for NDT or to replace with new wear ring during pump inspection and repair.	Rotating Equipment Manager	3/30/2017
