Re: 30-day Report for 8/13/16 Incident (Flaring)

1.0 Summary of Event

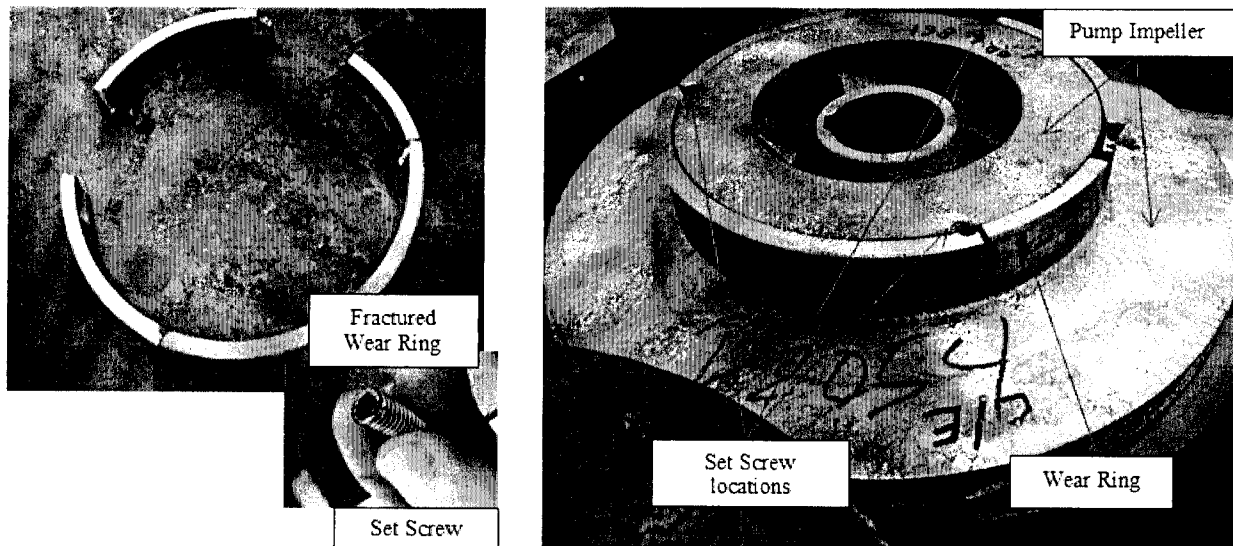
P-2054 Impeller and Fractured Wear Ring

The impeller wear ring was found to be fractured at the set screw locations, as seen in the picture above. The causes of this incident were deduced basis visual inspection of the fractured wear rings, pump overhaul history and process conditions around the time of the incident.

The cause of the fracture was likely due to an existing crack in the wear ring at a set screw location. It is likely that a process temperature change caused the existing crack to propagate and the wear ring fractured. Approximately 10 minutes prior to the overhead pump trip, an upstream air cooler (E-541) was actively placed online to decrease process temperature. The process temperature was decreased about 30°F and was operating within temperature limits.

The initial crack in the wear ring was likely due to the fact that the wear ring had been subject to thermal stresses over the life of the wear ring. Stress from thermal fatigue on the wear ring could be caused by pump start-up and shut-down activities or thermal fatigue could be caused by heat that was applied to the impeller, as part of common maintenance practice, for impeller removal from the shaft during pump overhauls.

The overhead pump (P-2054) was rebuilt with the existing impellers and a new shaft during the June 2016 overhaul. The pumps wear rings satisfied dimensional checks and visual inspections during the pump rebuild, and thus the pump was returned to service. Wear rings are left in place when visually inspected, however, making it difficult to identify cracks at the inner diameter of a set screw location.

Recommendation	Responsible Manager or Individual	Estimated Completion
1. Non-destructively test (NDT) P-2054 pump wear rings during inspection after incident and determine whether wear rings are to be replaced with new.	CMD Shop Inspector	COMPLETED
2. Update P-2044 "Pump Inspection Work Scope Template" to include evaluation of cast iron wear rings for non-destructive testing or replacement with new	CMD Shop Inspector	3/30/2017
3. Update Mechanical Equipment Guidelines - 020 "Wear Rings in Centrifugal Pumps" to include verbiage regarding evaluation of cast iron set-screwed wear rings for NDT or to replace with new wear ring during pump inspection and repair.	Rotating Equipment Manager	3/30/2017
