**Chevron Richmond Refinery
Causal Analysis Report - December 18, 2014 Reportable Flaring Event**

Chevron Richmond Refinery
Reportable Flaring Event

Event Date: December 18, 2014
SDA Level Instrument

Refinery Flare Event – Cause Investigation Report

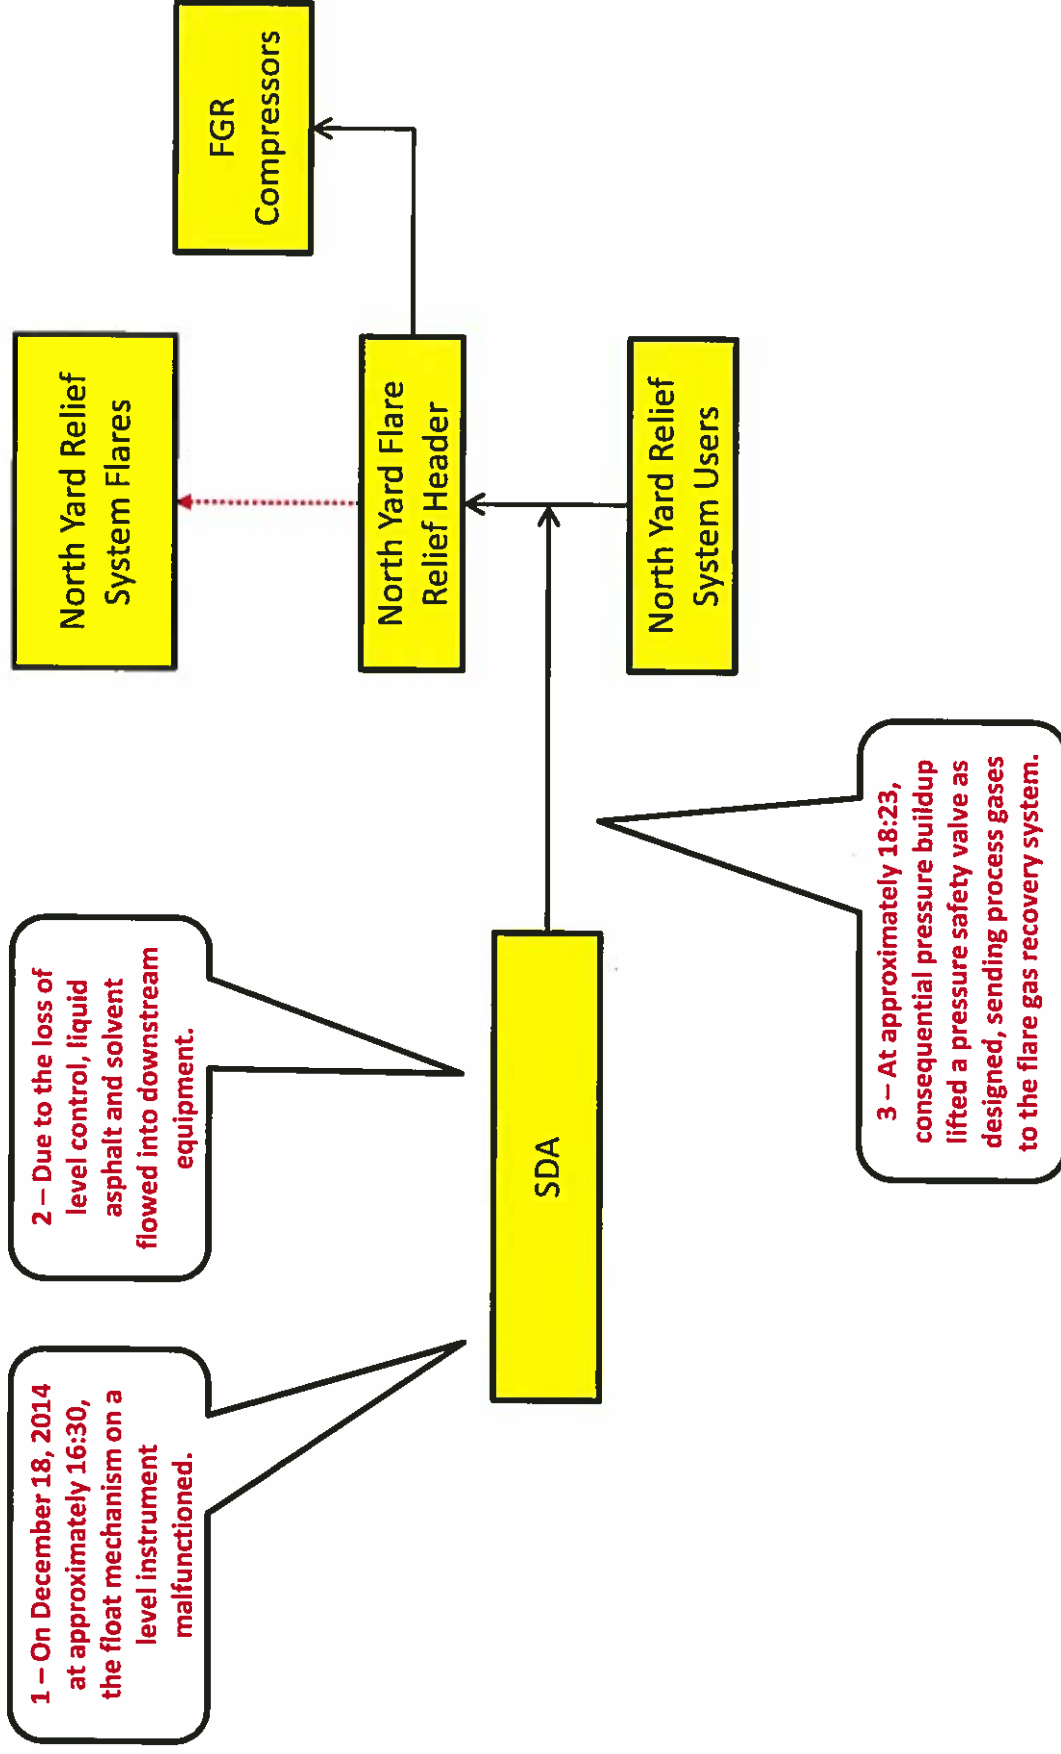
Attachment Ia

On December 18, 2014 at approximately 16:30, the float mechanism on a level instrument in the Solvent Deasphalting (SDA) unit in the Hydroprocessing Area Business Unit malfunctioned. The loss of level control resulted in the flow of liquid asphalt and solvent to downstream equipment. The asphalt and solvent decreased the cooling capacity of the downstream equipment in the solvent recovery system. At approximately 18:23, consequential pressure buildup lifted a pressure safety valve as designed thus sending process gases to the flare gas recovery system.

- The float-style level indicator, 67LI122A, stuck at approximately 40%. Due to this false low indication, the level controller, 67LC122, closed the level control valve in an attempt to reach the level setpoint of 45% and caused C-122 to overfill with asphalt. There was an active plan to install an analog nuclear level indication in Jan. 2015, and its installation is now complete.

- One contributing cause was a less-than-adequate response to high level alarm 67LAH122, which had a recent history of numerous spurious alarms. There was an acknowledgement of the alarm, but neither the day shift nor night shift control board operator (CBO) took action to investigate the situation.
- The second contributing cause was related to gaps in the CBO turnover. Had the panel alarm, 67LAH122, been explicitly discussed during turnover, the CBOs would have likely acted sooner to investigate the alarm and correct the high asphalt level in C-122.

1. Complete the installation of the analog nuclear level indication device.

2. Consider adding low output alarms on asphalt level controllers 67LC102 and 67LC122

3. Consider limiting the minimum automatic closure of asphalt level control valves 67LV102 and 67LV122.

4. Conduct a level instrumentation review/analysis of C-102,103,122, & 123. The review should include determining appropriate reliable level indication technologies, understanding operating level ranges within the vessels, and determining the appropriate elevations of level taps and physical locations of instruments on equipment. Develop an appropriate control and alarm strategy to allow sufficient operator response time while providing proper product separation. Ensure appropriate maintenance strategies are in place for level indicators.
