RE: Seventh Update to the 30-Day Report for the CWS Level 3 Event of August 6, 2012

Event Title: Richmond Refinery 4 Crude Unit Leak and Fire

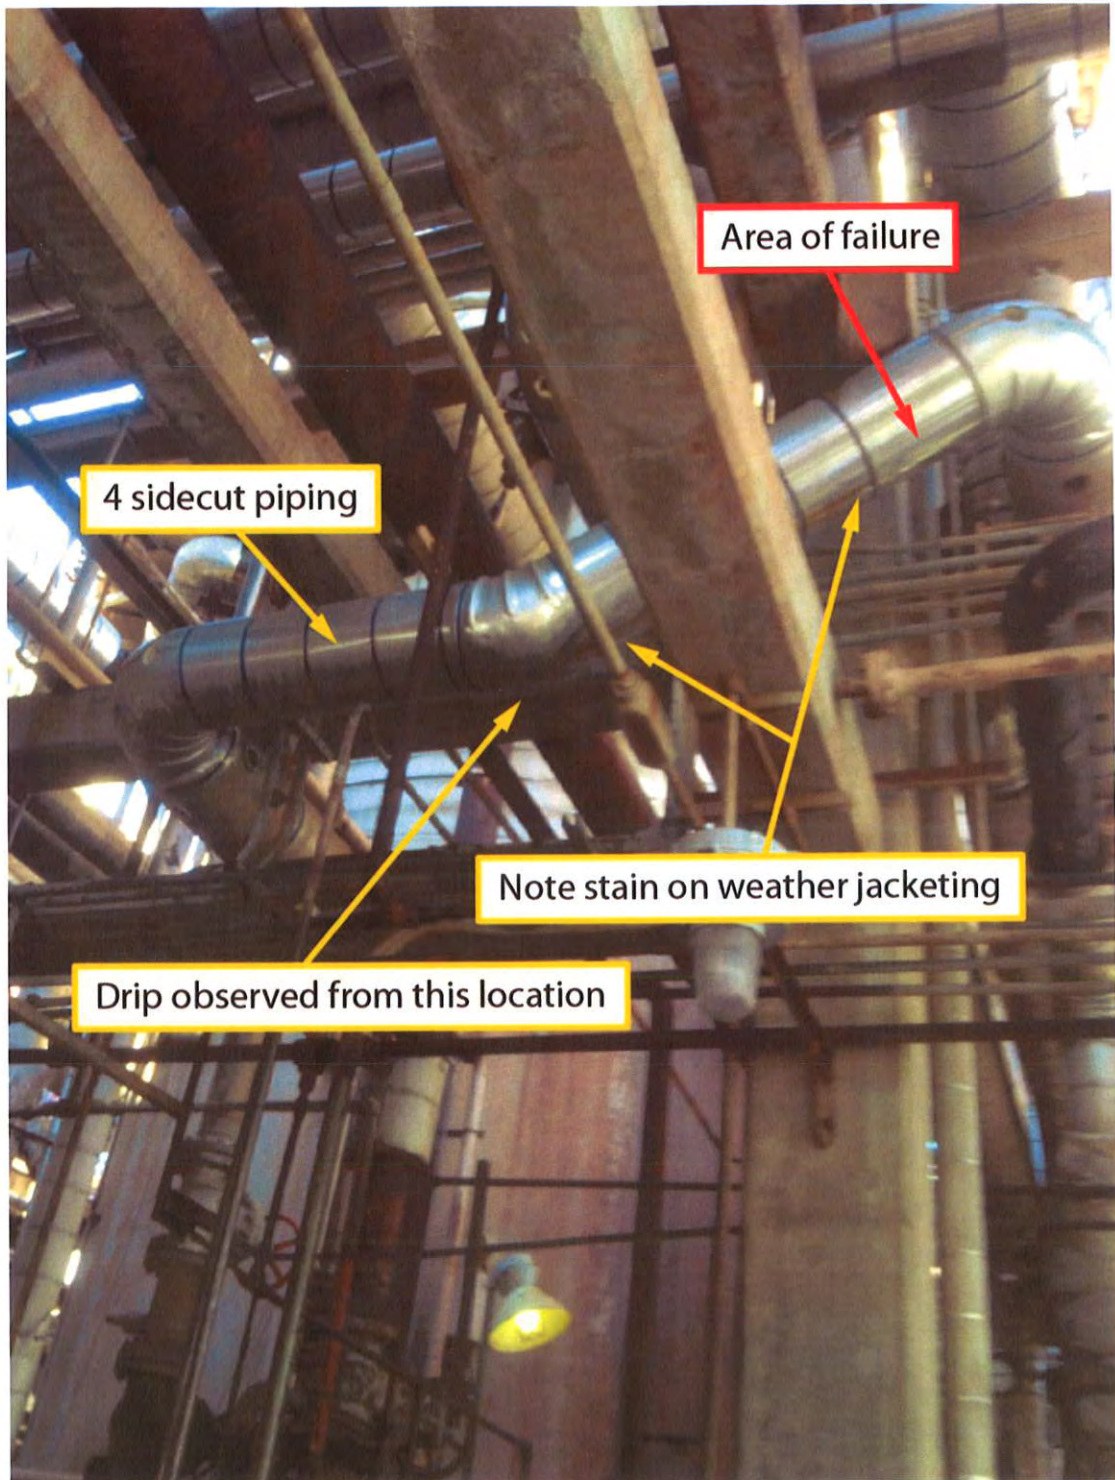
Figure 4. Photograph taken by STL2 during the initial response to the leak, but before the pipe rupture. The area where the rupture subsequently occurred (indicated by a red arrow) is approximately 16 feet from the ground.

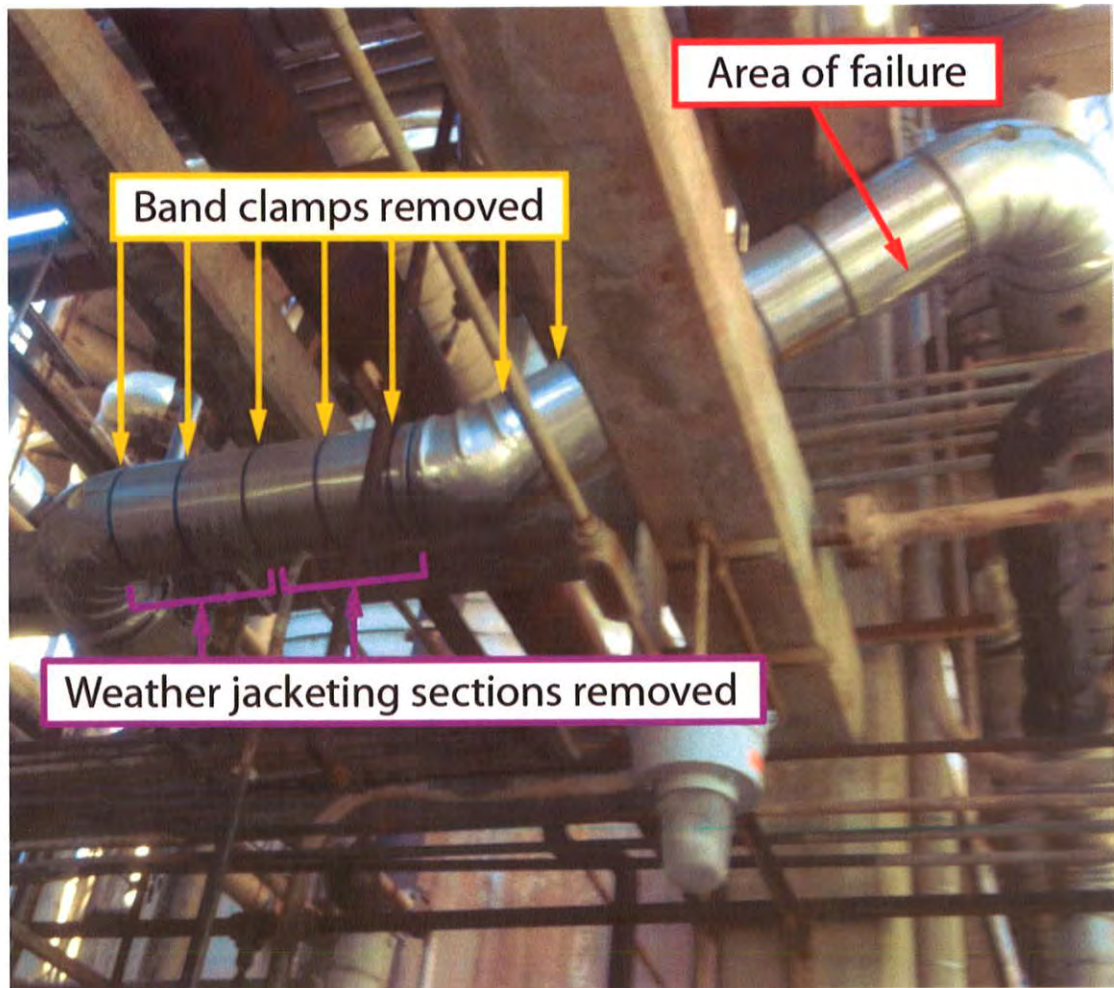
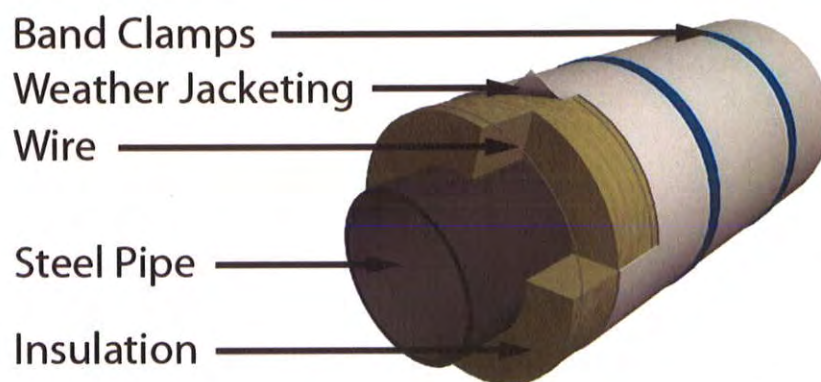
Figure 5. The steel pipe was encapsulated by insulation held in place by wire, which was covered by aluminum weather jacketing held in place with band clamps (bottom). The firefighters cut several band clamps (marked with yellow arrows) with pliers and removed two sections of the weather jacketing from the piping (marked with purple brackets).

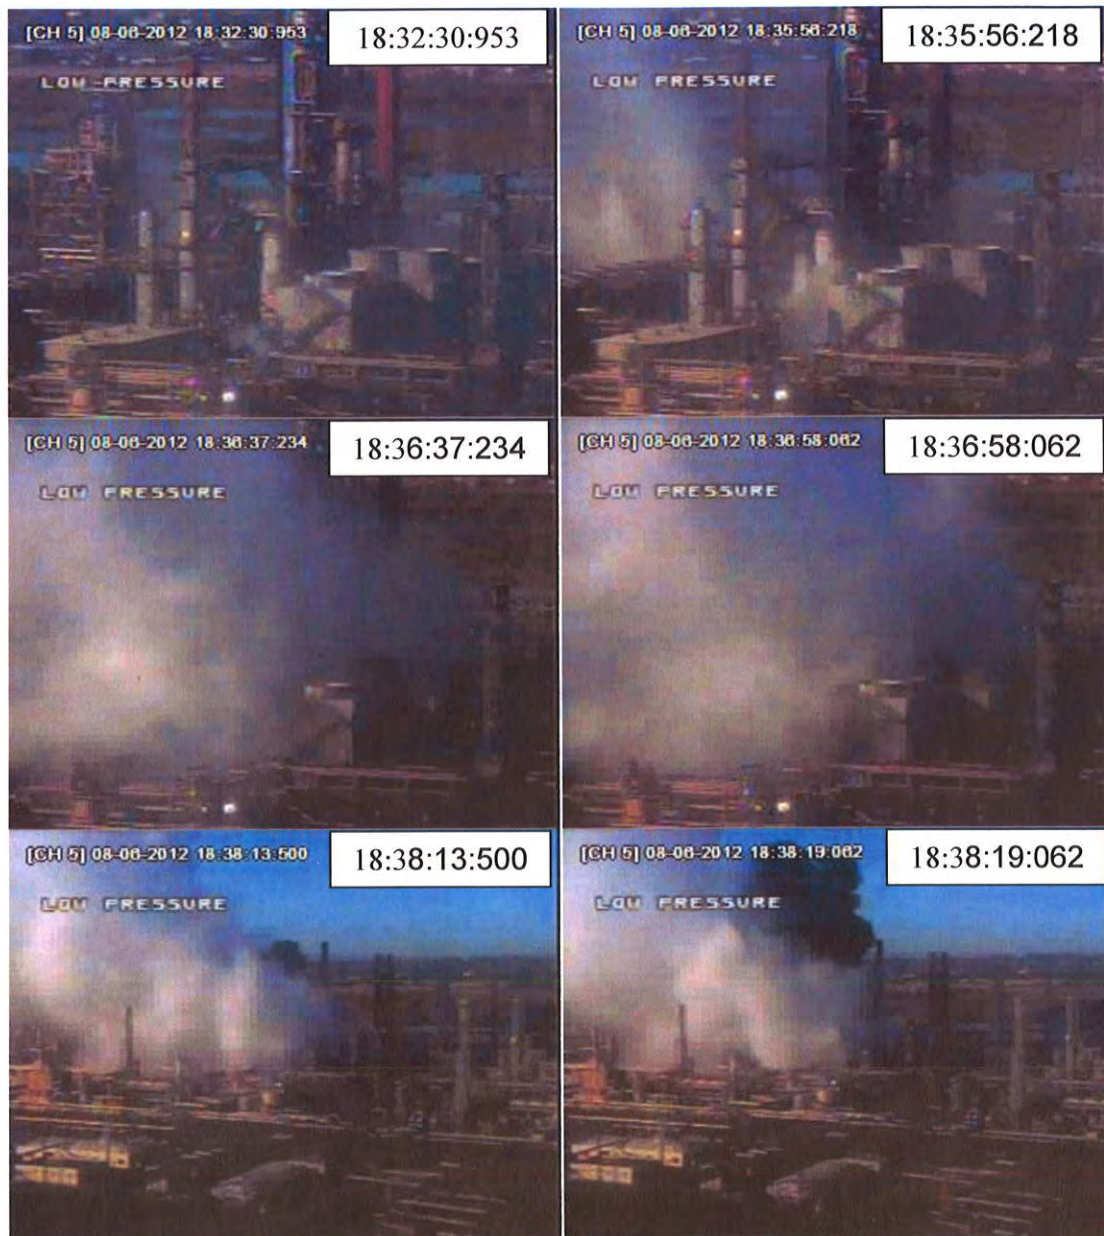
Figure 6. CUSA surveillance camera showing the 4CU (top left). A white cloud is shown forming (top-right and middle-right/left) for approximately 2 minutes and 30 seconds after the leak escalated and before the fire ignited (bottom, camera had been zoomed out). (The clock in these images is approximately 5-7 minutes ahead of actual time.)

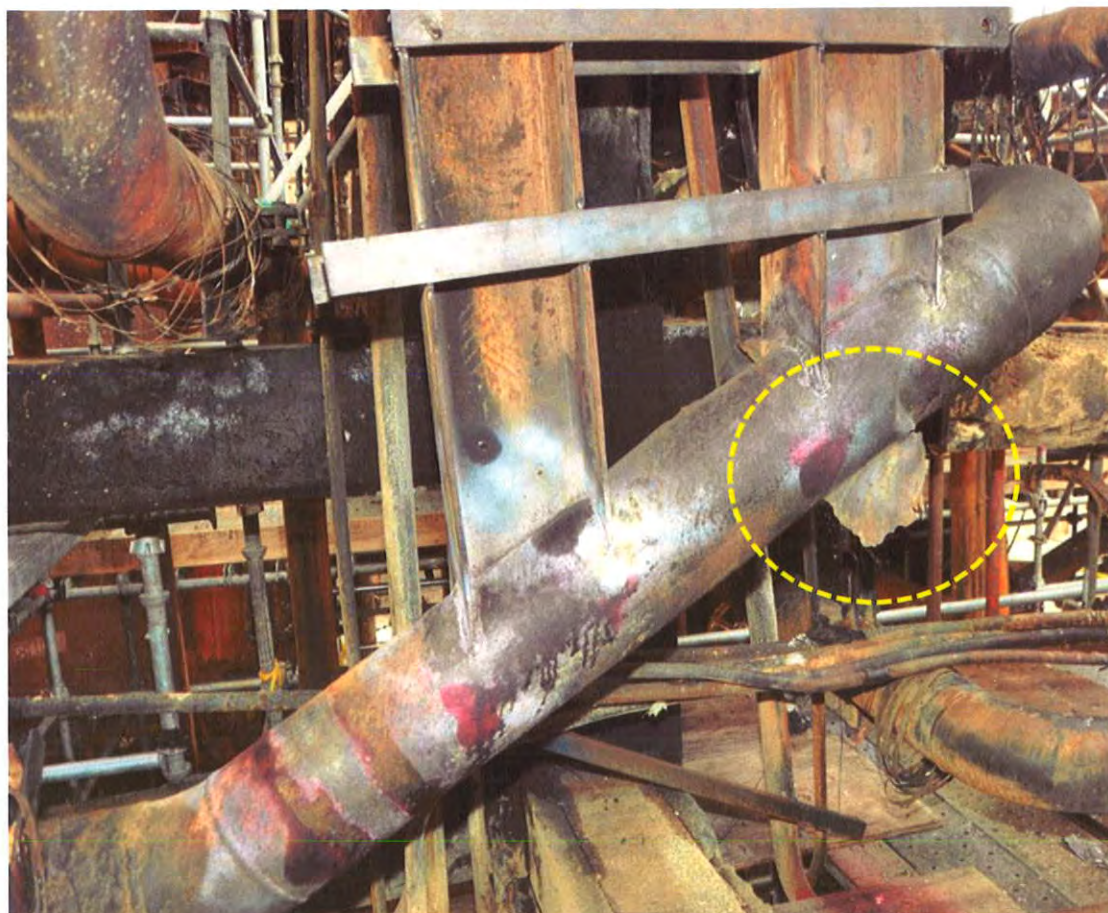
Figure 7. Photograph of the ruptured pipe component during inspection prior to removal. Area of the rupture is circled in yellow. (This photograph shows the same sloped portion of the pipe component shown in Figure 5.)

resulting in rupture. The corrosion pattern observed is considered “uniform thinning,” and is consistent with sulfidation corrosion.

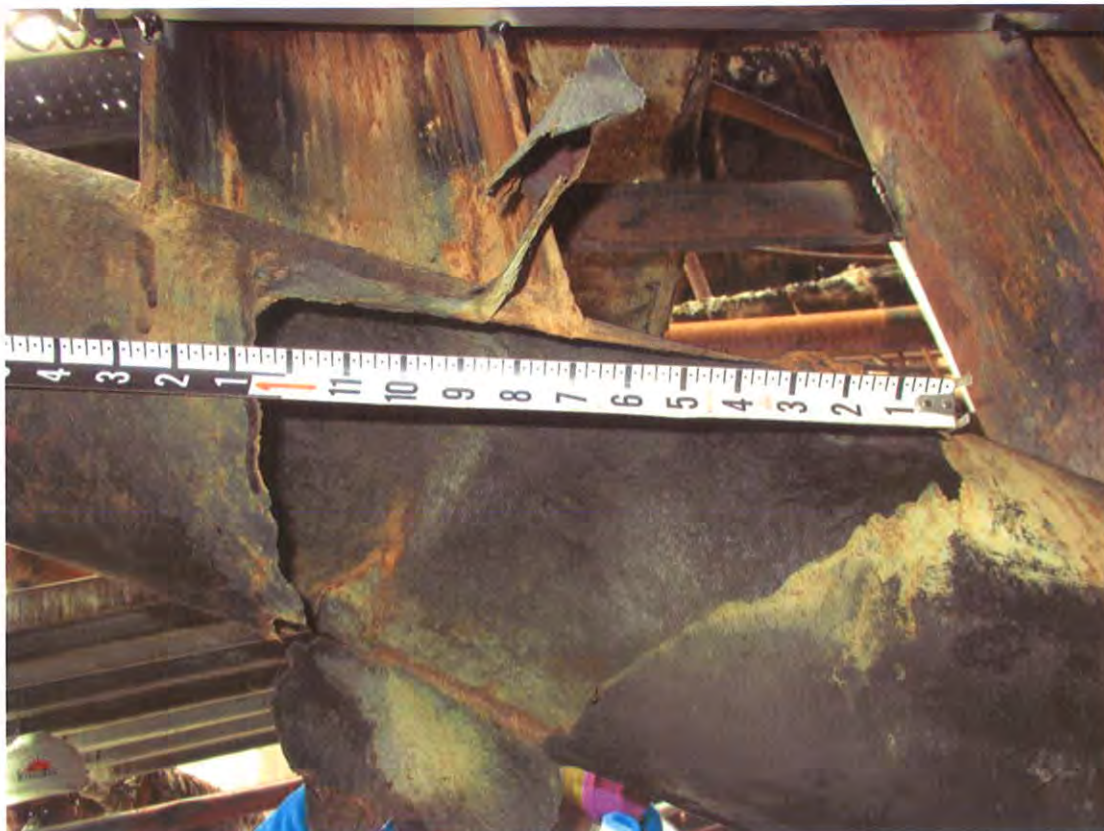
Figure 8. Close-up photograph of the ruptured pipe component taken during the inspection prior to removal.

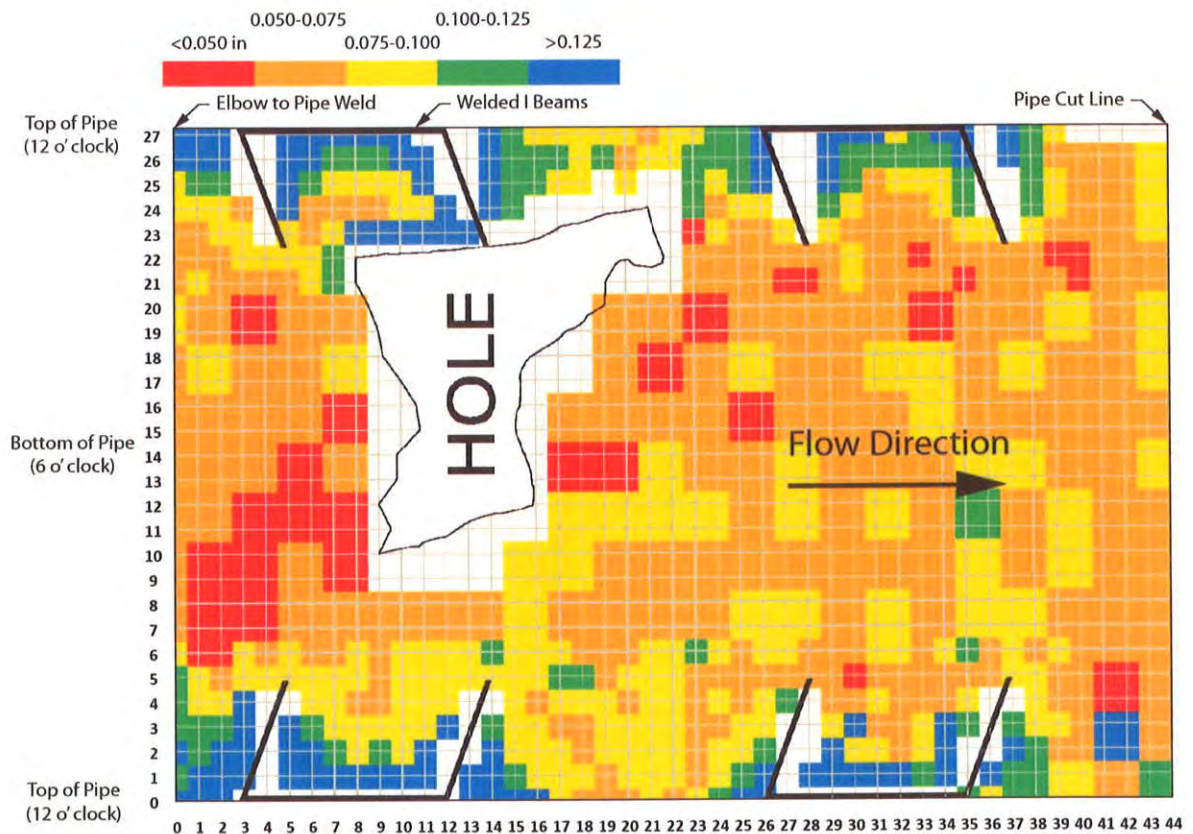
During the laboratory analysis at Anamet, thickness measurements were taken on the ruptured pipe component on a grid layout, as shown in Figure 9. Virtually the entire 27-inch circumference and 44-inch length of the ruptured pipe component had thinned to less than 0.10 inches, with only a few readings in the vicinity of the welded pipe guide attachments showing higher values.¹⁰ An ASME Code B31.3¹¹ analysis conducted by the Investigation Team determined that, in the area where the 4SC pipe ruptured, the minimum wall thickness required for containment is approximately 0.072 inches. The measured wall thicknesses of the ruptured pipe component were less than 0.072 inches (Figure 9).

Figure 9. Thickness measurement results from the ruptured pipe component. Virtually the entire 27-inch circumference and 44-inch length of the ruptured pipe component had thinned to less than 0.10 inches, consistent with sulfidation corrosion. The graphic represents the pipe as sliced longitudinally at the top of the pipe (12 o'clock) and rolled out flat. The areas in white could not be measured.

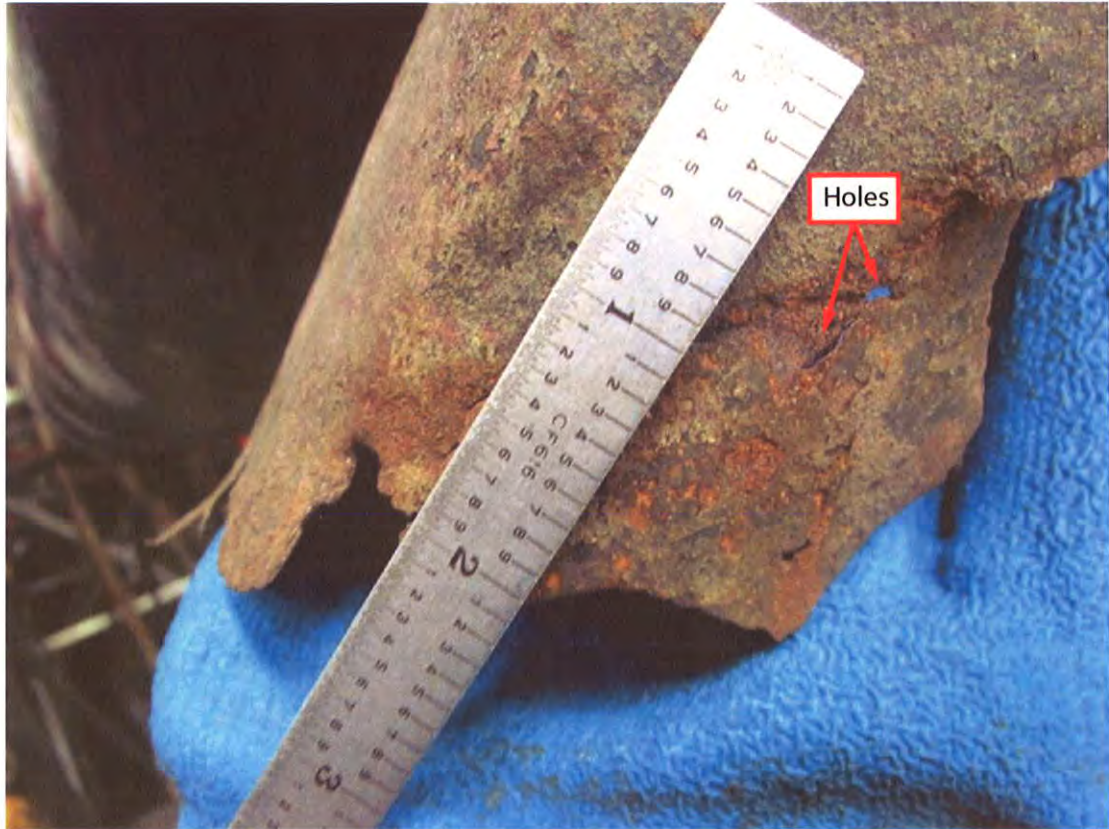
Figure 10. Photograph of one of the metal flaps associated with the 4SC rupture. Small perforations are visible in the flap.

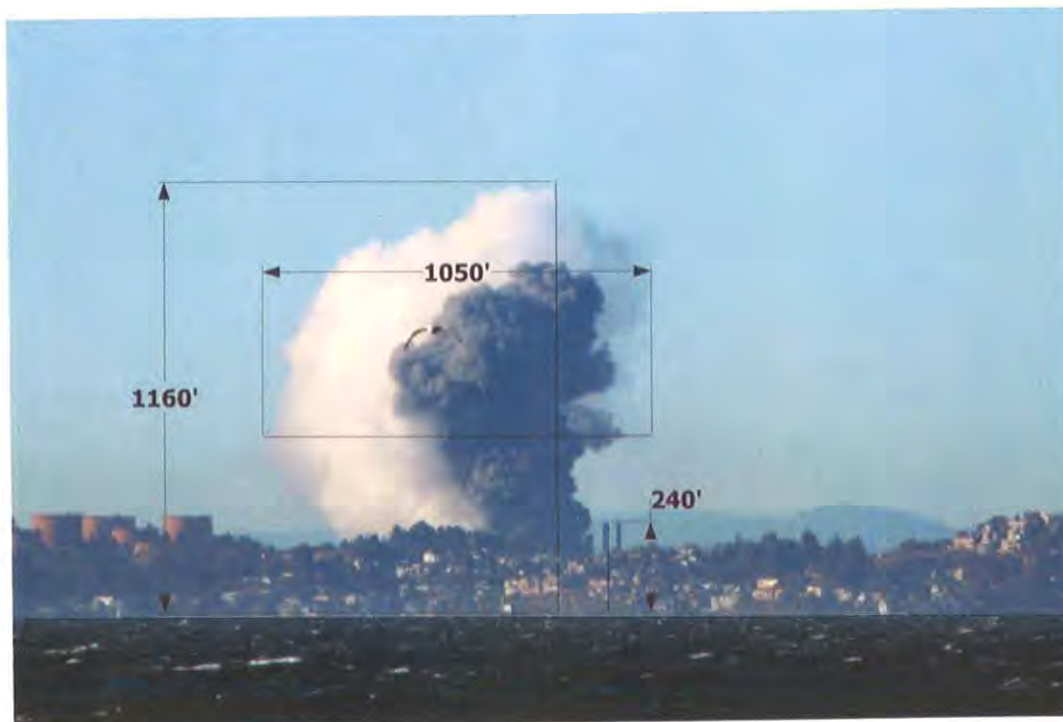
Figure 13. Estimated size of the white cloud utilizing a photograph taken at Pier 39 in San Francisco. The 240 foot dimension shows the height of the 4CU furnace stacks.

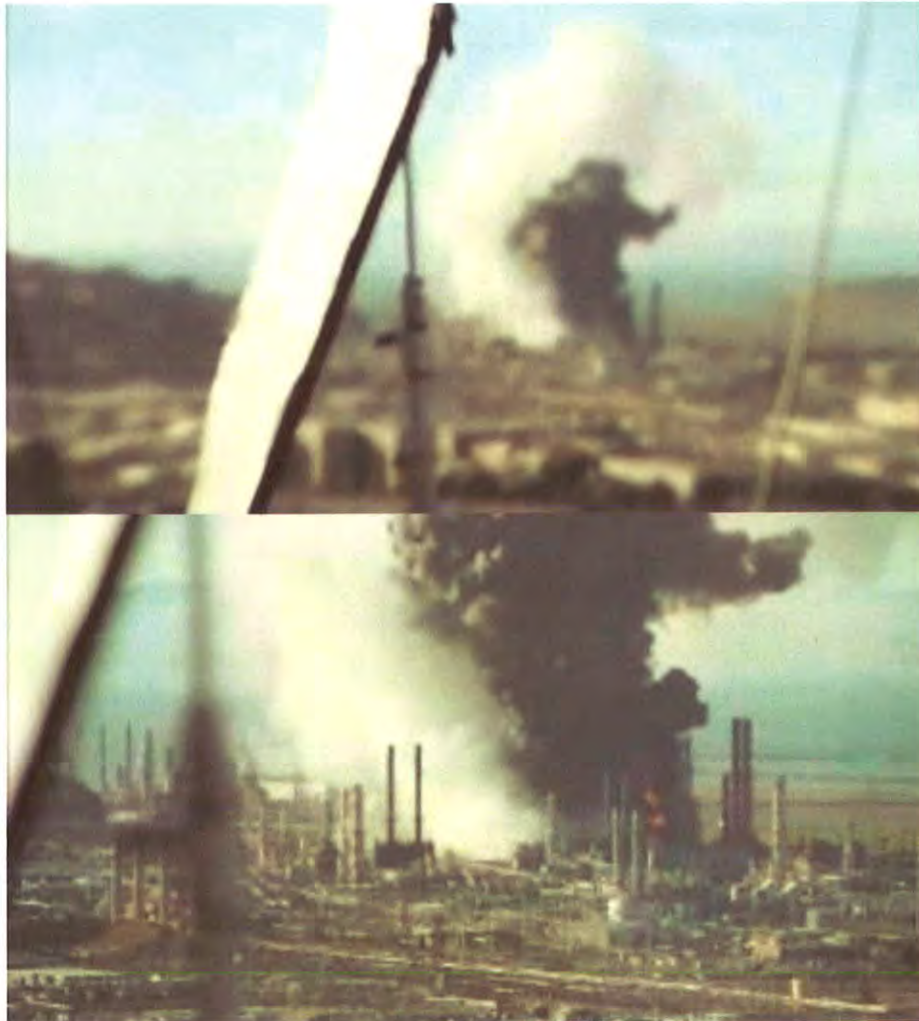
Figure 14. Stills from video footage taken from Marine View Avenue in Point Richmond that shows the formation of the black plume shortly after ignition of the fire (top), and after continued burning (bottom).

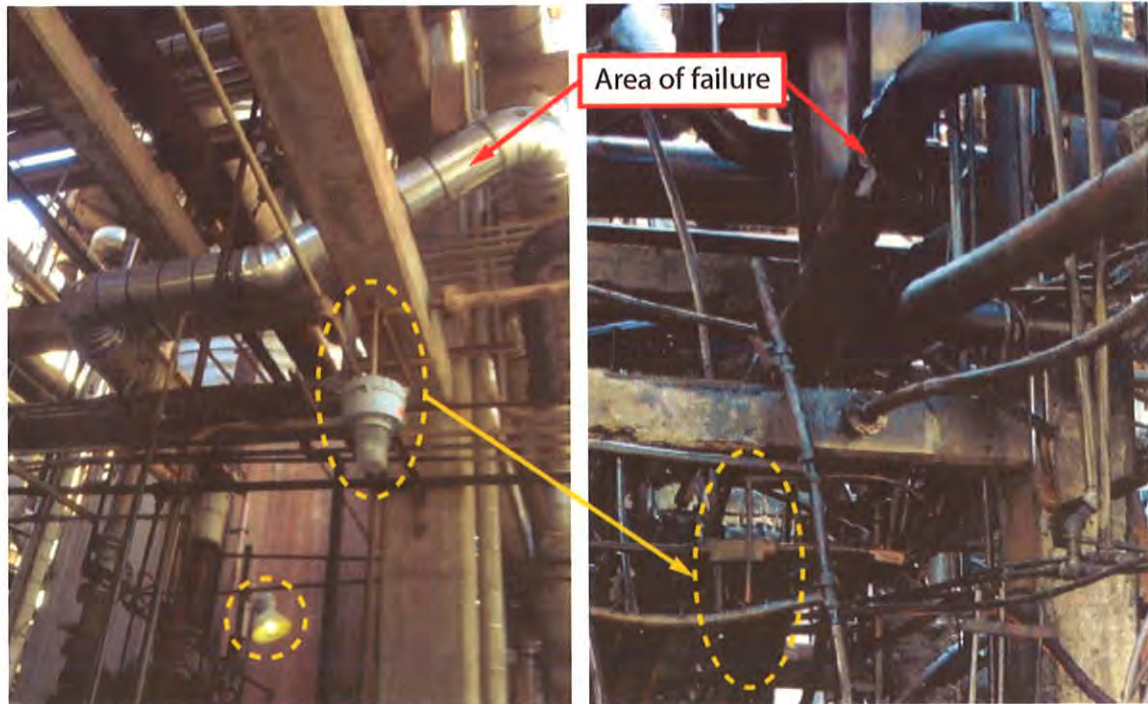
Figure 15. Lighting fixtures at the time the leak was discovered (photograph taken during the initial response) (left); and missing light after the Incident (right).

It is possible that the flow of hot liquid from the rupture location caused the lighting fixture to dislodge, exposing the wiring that provided power. After the white cloud formed and obscured the photo cell that controls the light, the lighting circuit may have energized. This photo cell was inspected and tested post-Incident. Testing showed that the photo cell activated at low light levels. With the circuit energized and wires exposed, this fixture could have provided an ignition source for the fire. This scenario also is possible if the bulb was burned out pre-Incident. Similarly, the photo shows the lower light fixture energized; this too could have provided an ignition source if the light fixture was dislodged by the flow of hot liquid.
