**REPORT
FIVE YEAR REVIEW
DREW MIDDLE AND
SOUTH PROPERTY
CITY OF RICHMOND
PARKWAY PROJECT
RICHMOND, CALIFORNIA**

**Job No. 28068082
MARCH 2012**

**REVISED
MARCH 2013**

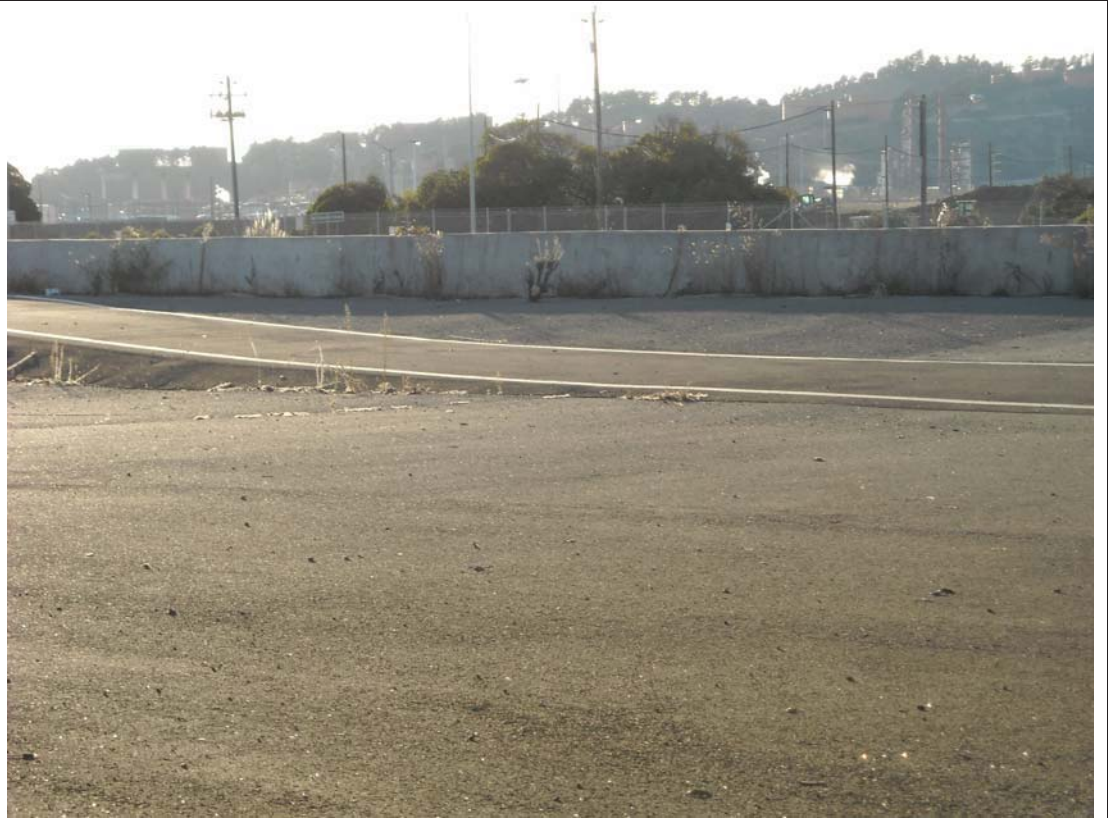
During the December 2011 cap inspection, the cap and fence were evaluated for integrity. During the reconnaissance, the asphalt portion of the cap adjacent to the roadway was determined to be intact with no significant cracks visible. However, along the perimeter of where the asphalt cap adjoins the concrete sidewalk, near the intersection of Castro Street and Hensley Street, there is vegetation growing from within the seam where the two meet. Vegetation was noted growing in the area along the eastern side of where the Bay Trail cap modification joins the original cap. Additionally, vegetation growth was noted in the shallow drainage swale on the portion of the site located on the west side of Castro Street. It appears that soil accumulates during storm water runoff in the shallow swale and provides the substrate for the growth of vegetation.

View looking to the south across the Parkway. The Chevron refinery is in the background of the photo. Note the weeds growing up between the K rail and the edge of the asphalt cap.

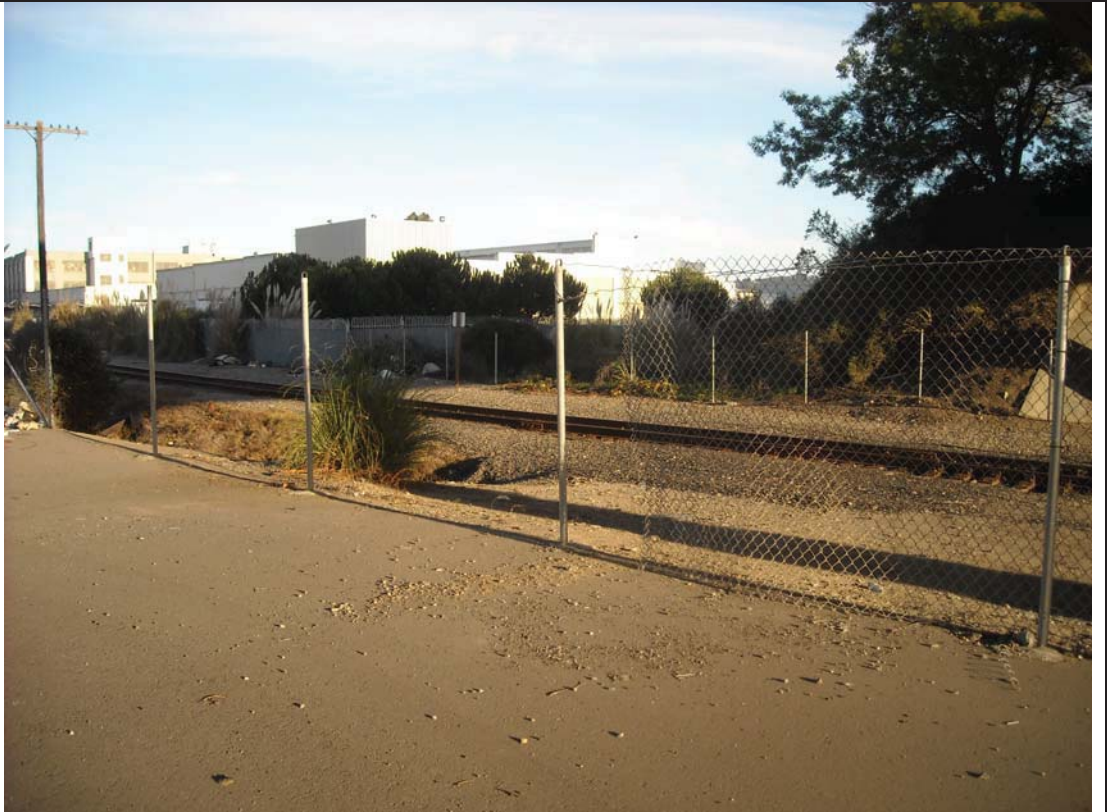
A section of the chain-link perimeter fence that separates the site from the Southern Pacific Railroad tracks along the north eastern side of the site had been removed (it appears the fence has been stolen). Additionally, a section of the fencing on the portion of the site on the western side of Castro Street was damaged allowing access to this part of the site. It should be noted that since the extension of the Bay Trail was completed through the site, this portion of the site can be accessed by the public. The signs required to be posted by DTSC were present along the perimeter fencing at the site.

The perimeter fence was missing along the northeast portion of the site adjacent to the Southern Pacific railroad tracks. Additionally, the fence had been damaged on the northern end of the portion of the site on the western side of Castro Street. Signs indicating the site contains hazardous wastes were posted.

View of the missing fence in the northeast corner of the Middle Drew Property.

The missing and damaged portion of the fence needs to be repaired in order for the remedy to continue to be effective in keeping trespassers off of the cap and to mitigate direct access to the Southern Pacific right-of-way located along the eastern portion of the site. The cap and fence should continue to be evaluated during future cap inspection events. As required by the agreement with the DTSC, signs indicating the site contains hazardous substances and that no grading, excavation or construction activities can occur without permission from the DTSC have been posted on the perimeter fence. Inspection to ensure the signs are still in place should be conducted at the same time as future cap inspections.

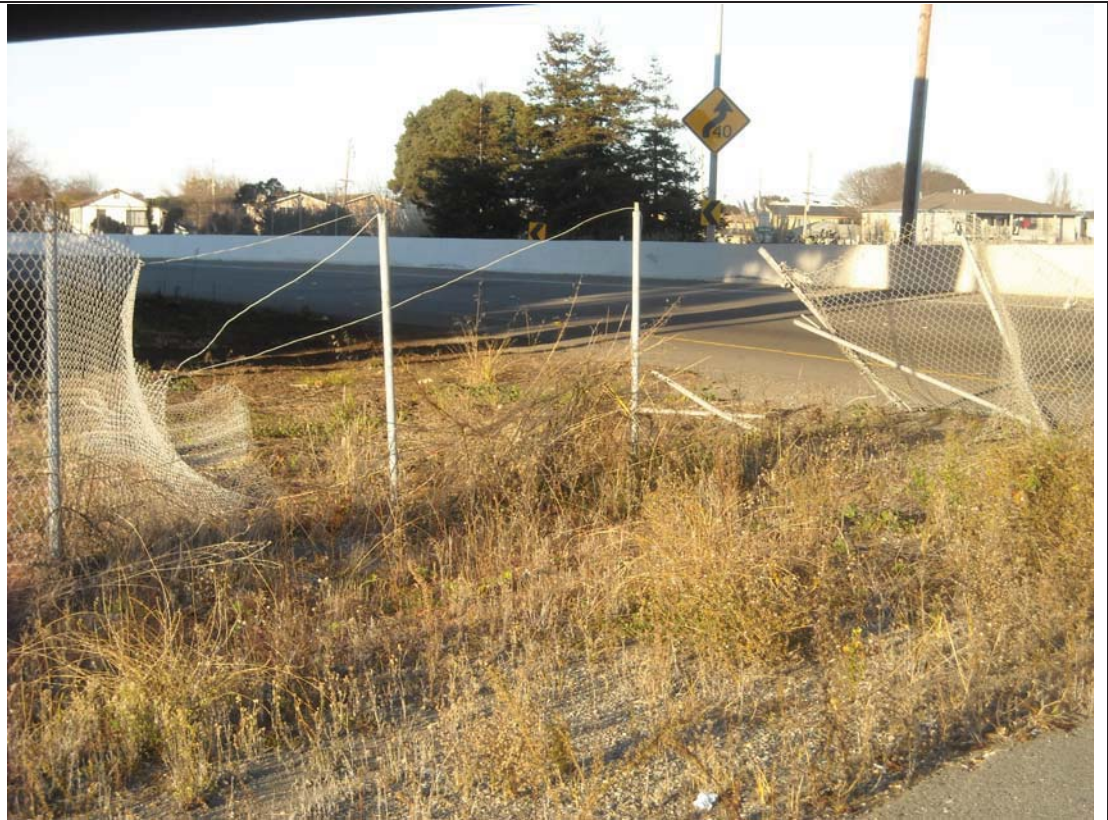
View of the damaged fence on the northern portion of the western side of the Middle Drew property.
