Independent Investigation of the Catalyst Release from Martinez Refining Company on November 24-25, 2022

Report prepared by
Scott Berger and Associates, LLC

Version 1.2
December 15, 2023

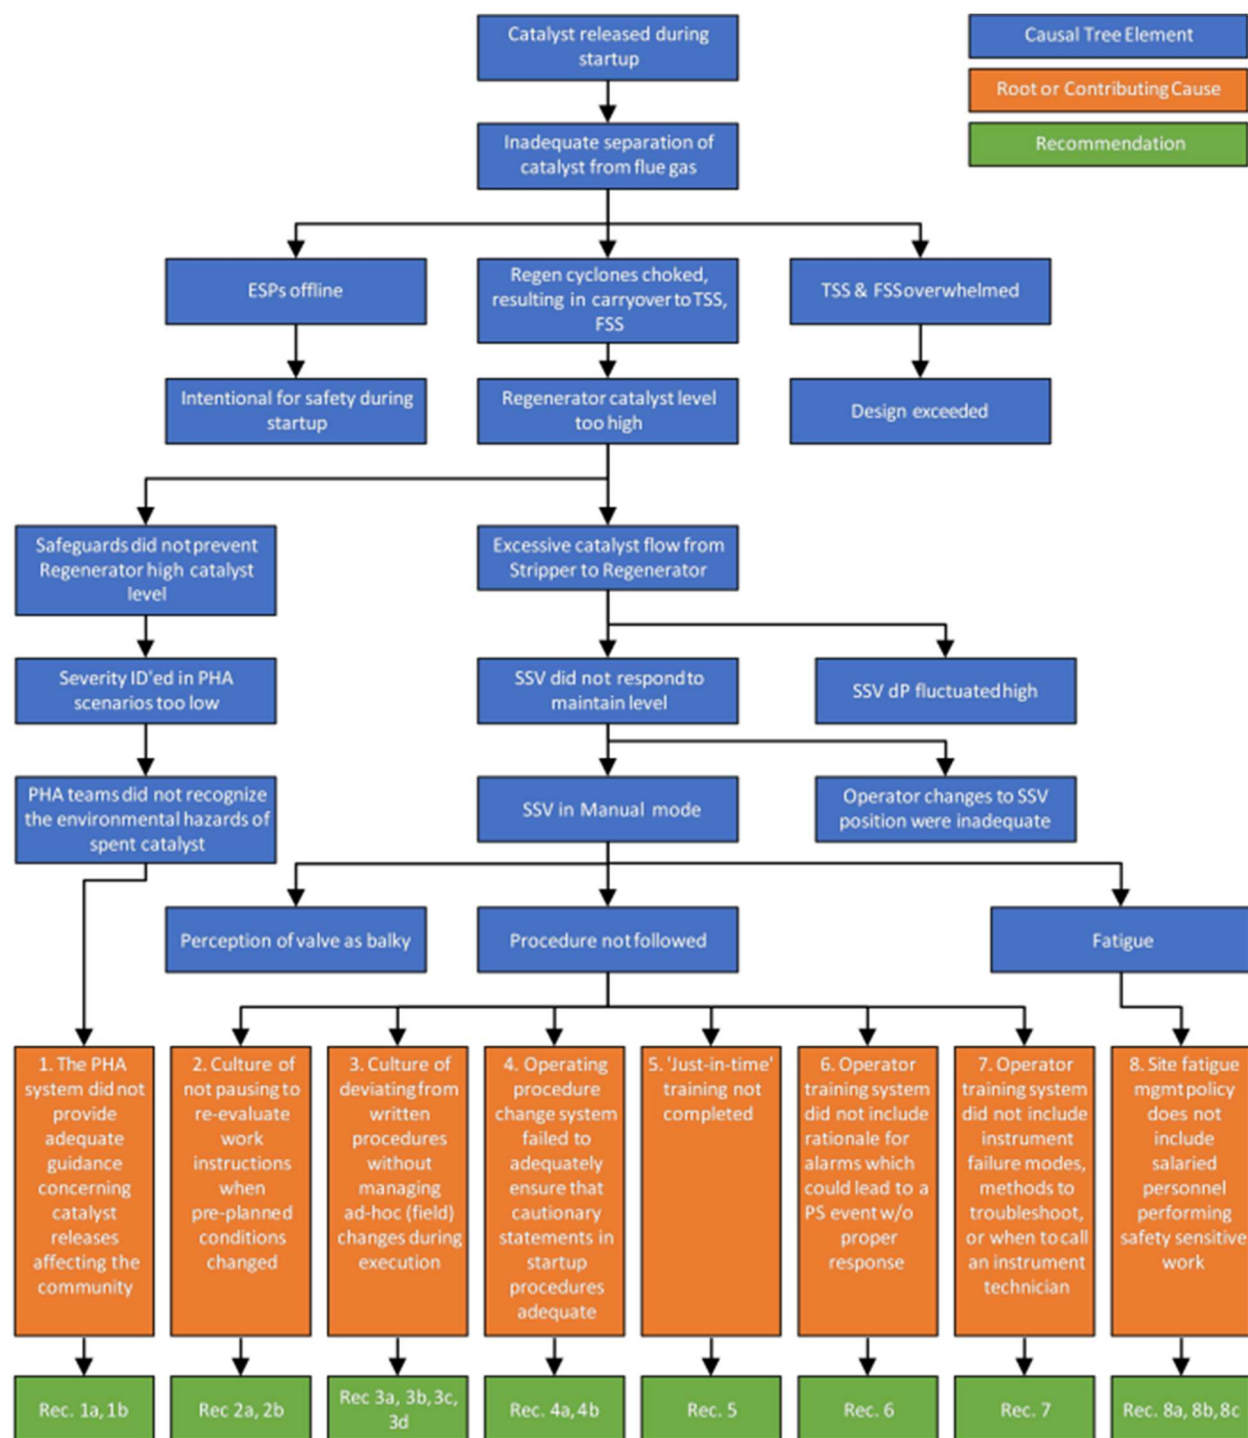
Figure 2: Causal tree of November 24-25, 2022, Catalyst Release Incident

The causal tree for this incident is shown below (Figure 2). The key links in the causal chain are described in this section.

Evaluation of PHA scenarios as “No Action Required”: Long before this incident, two separate process hazards analyses (PHAs) had been conducted. Each considered causes that could lead to catalyst carryover: the Shell Oil Products CCU PHA in 2018, and the MRC/PBF CO Boilers PHA in 2022. Each PHA team identified scenarios with a potential for a severity two (2) environmental consequence (meaning, minor or no lasting environmental effect, RQ with agency notification, or short duration remediation). After evaluating the 2022 catalyst release, CCHMP determined that the event was a Community Warning System (CWS) Level 2 or higher MCAR due to the need to clean up the released catalyst. The Shell and MRC/PBF assigns a consequence category of 3 if environmental cleanup is required.

The failure to ensure the SSV was in Auto before introducing feed is a deviation from procedures that had a direct causal link to the incident. Several other deviations from procedures (discussed in section VI.C) served as distractions to personnel and therefore contributed to the incident.
