RE: Seventh Update to the 30-Day Report for the CWS Level 3 Event of August 6, 2012

Event Title: Richmond Refinery 4 Crude Unit Leak and Fire

1. Introduction

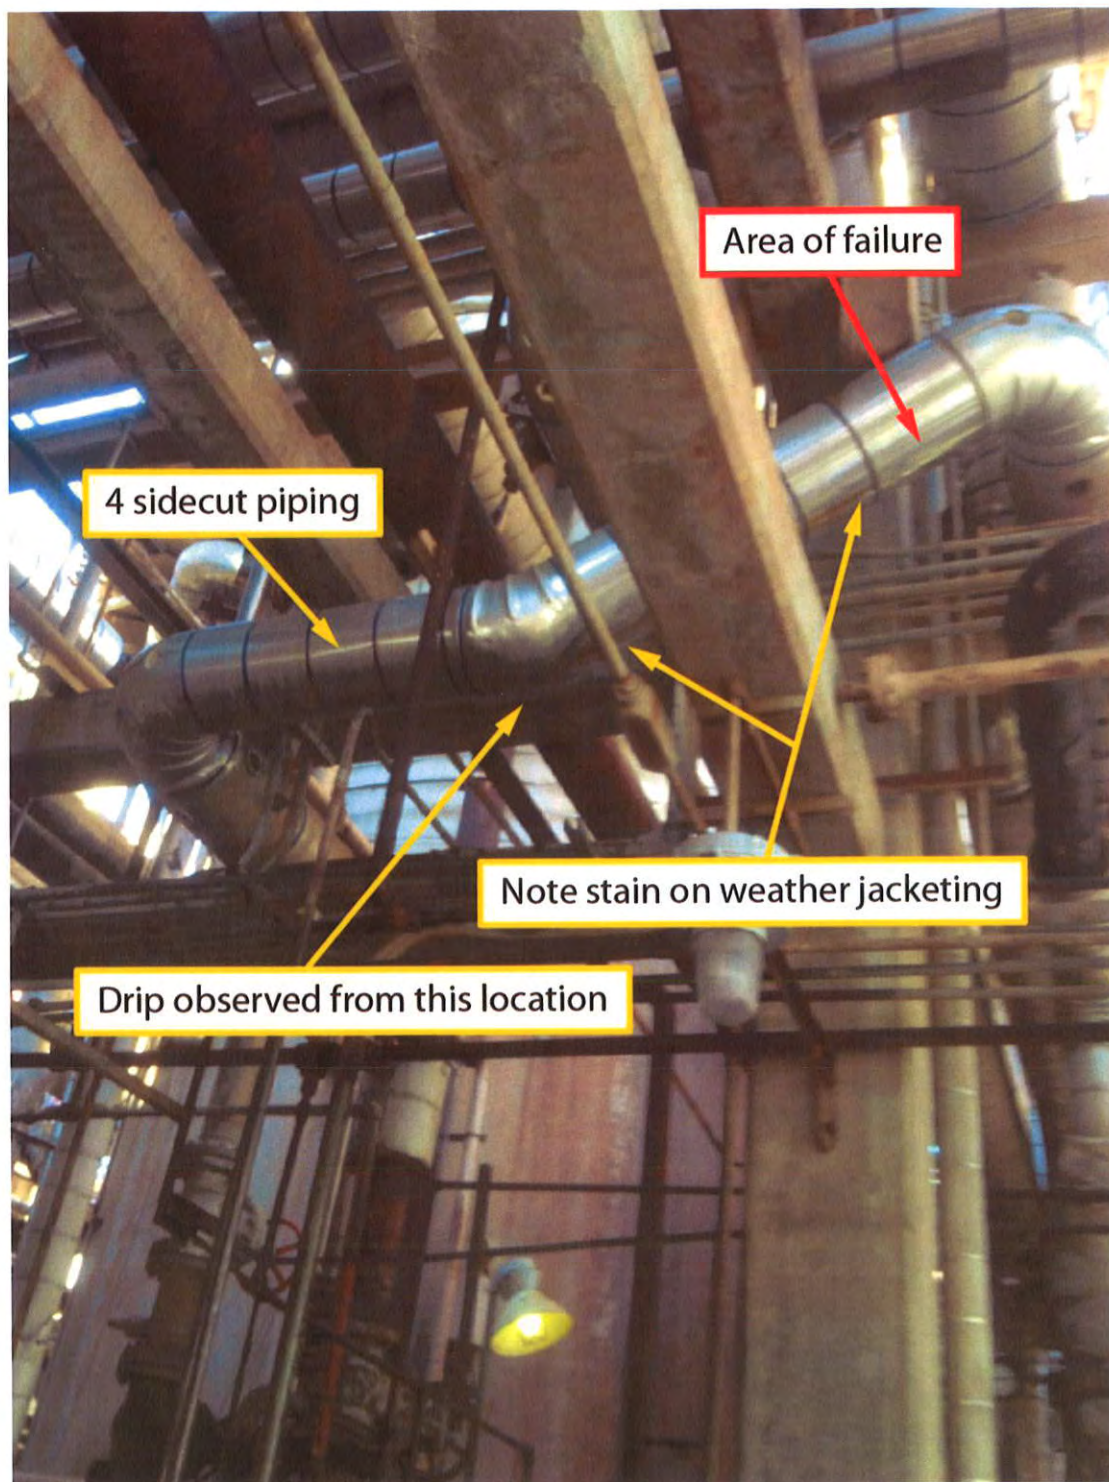
Figure 4. Photograph taken by STL2 during the initial response to the leak, but before the pipe rupture. The area where the rupture subsequently occurred (indicated by a red arrow) is approximately 16 feet from the ground.

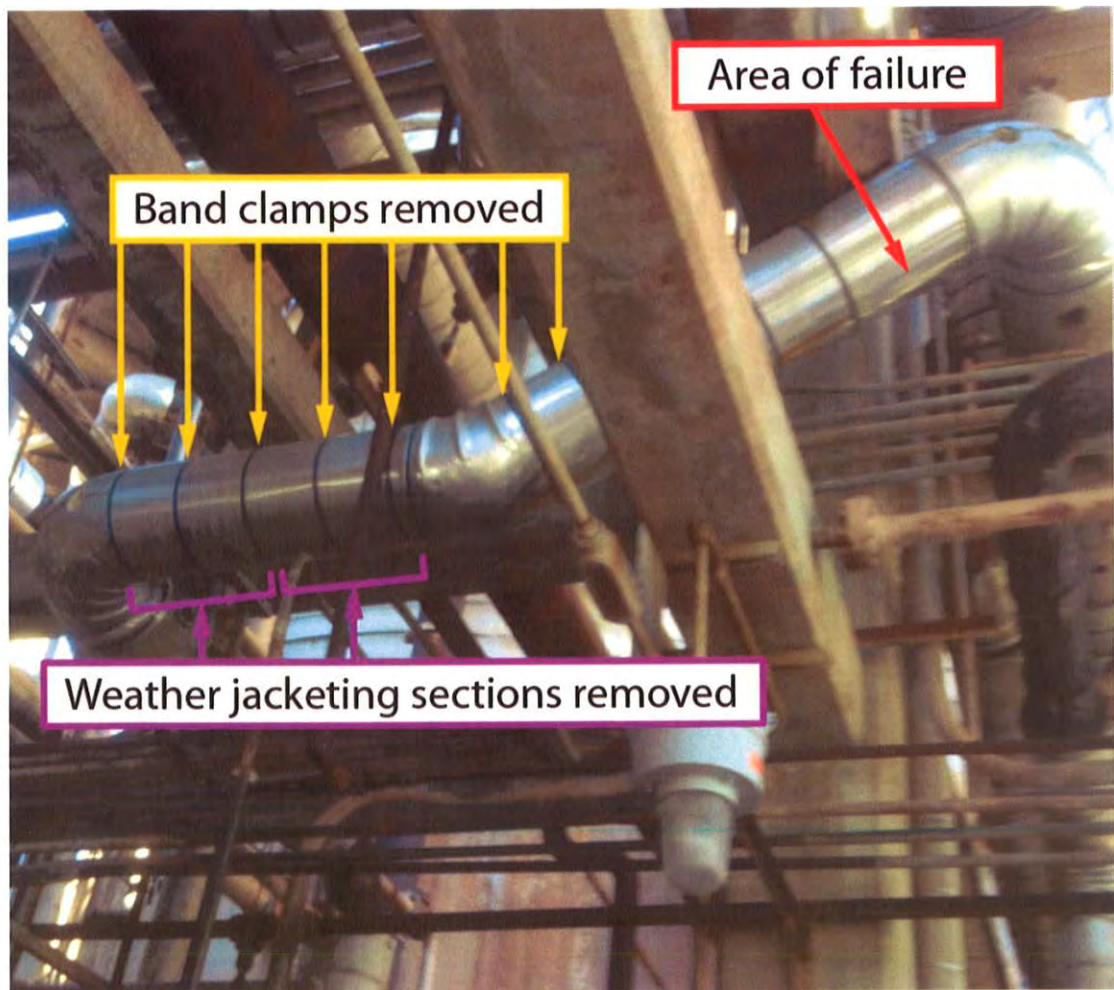
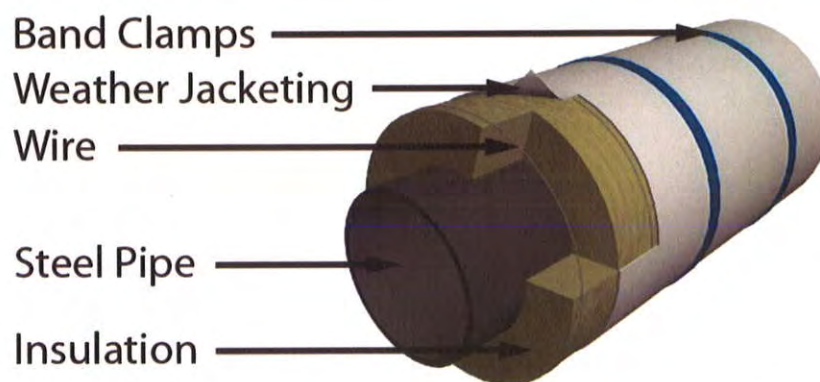
Figure 5. The steel pipe was encapsulated by insulation held in place by wire, which was covered by aluminum weather jacketing held in place with band clamps (bottom). The firefighters cut several band clamps (marked with yellow arrows) with pliers and removed two sections of the weather jacketing from the piping (marked with purple brackets).

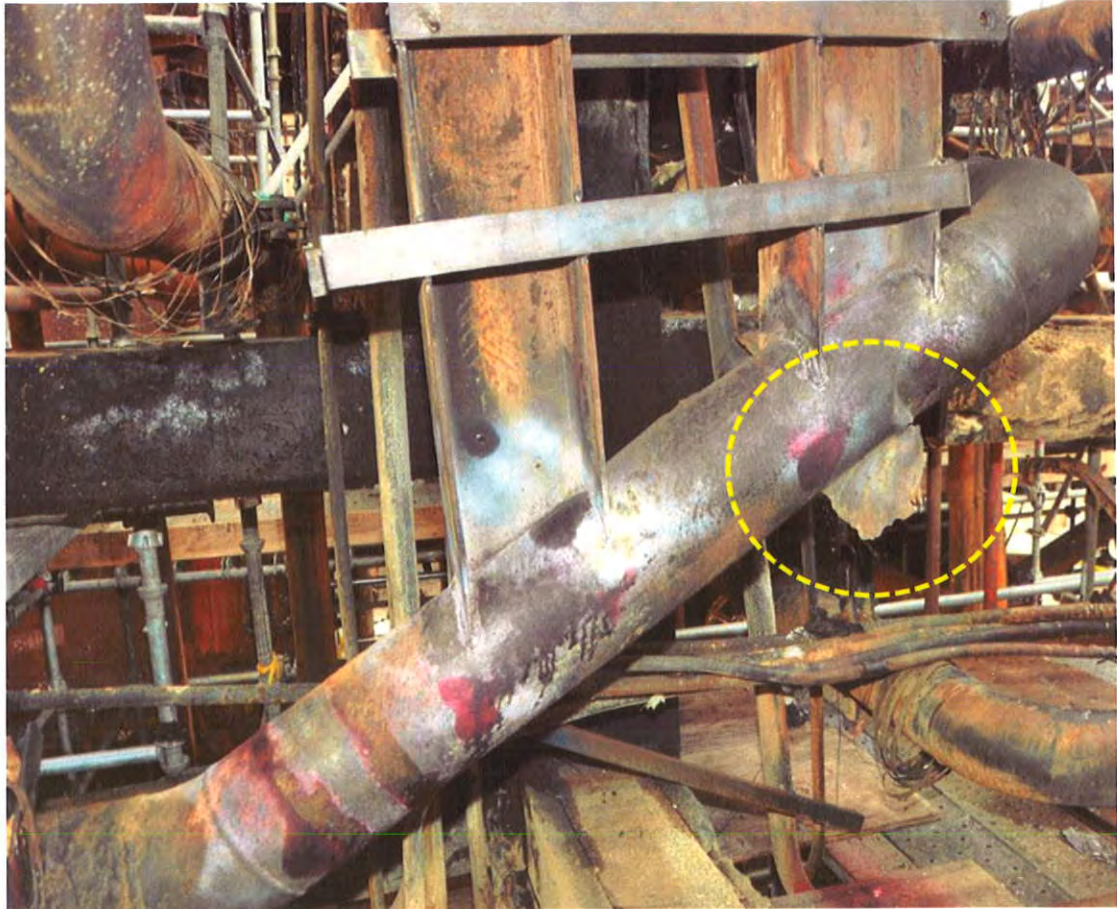
Figure 7. Photograph of the ruptured pipe component during inspection prior to removal. Area of the rupture is circled in yellow. (This photograph shows the same sloped portion of the pipe component shown in Figure 5.)

resulting in rupture. The corrosion pattern observed is considered “uniform thinning,” and is consistent with sulfidation corrosion.

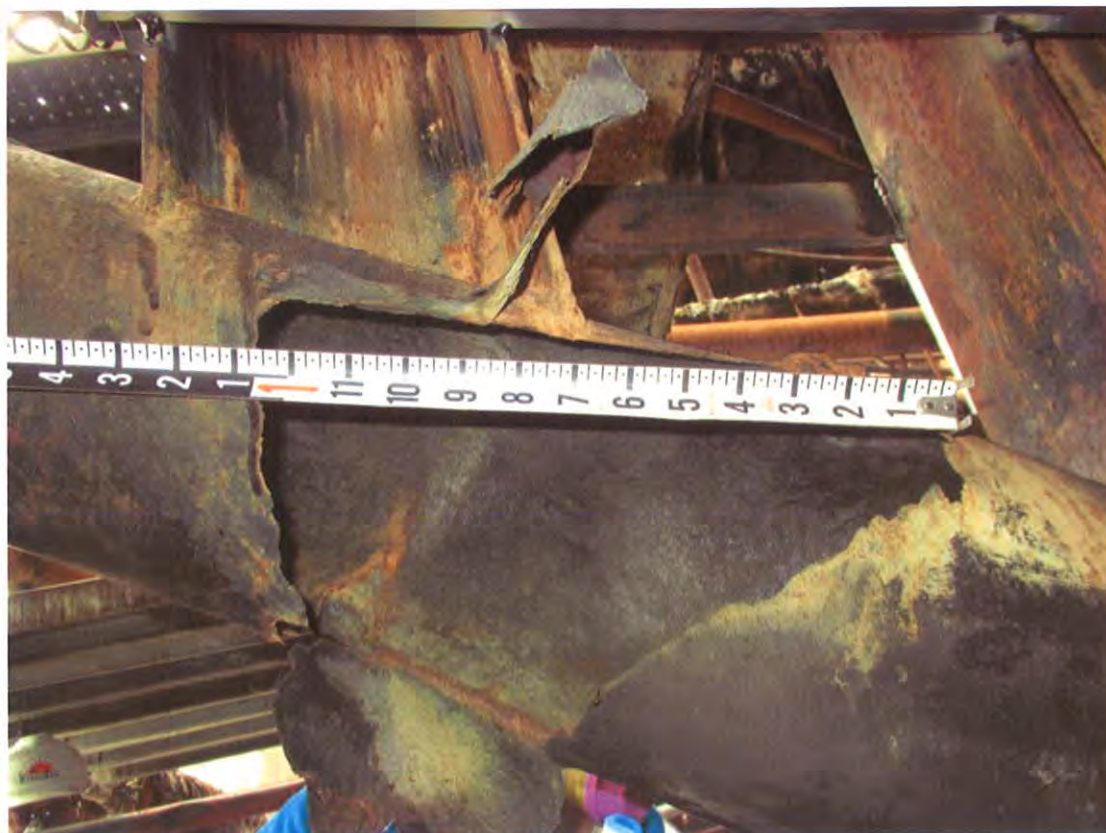
Figure 8. Close-up photograph of the ruptured pipe component taken during the inspection prior to removal.

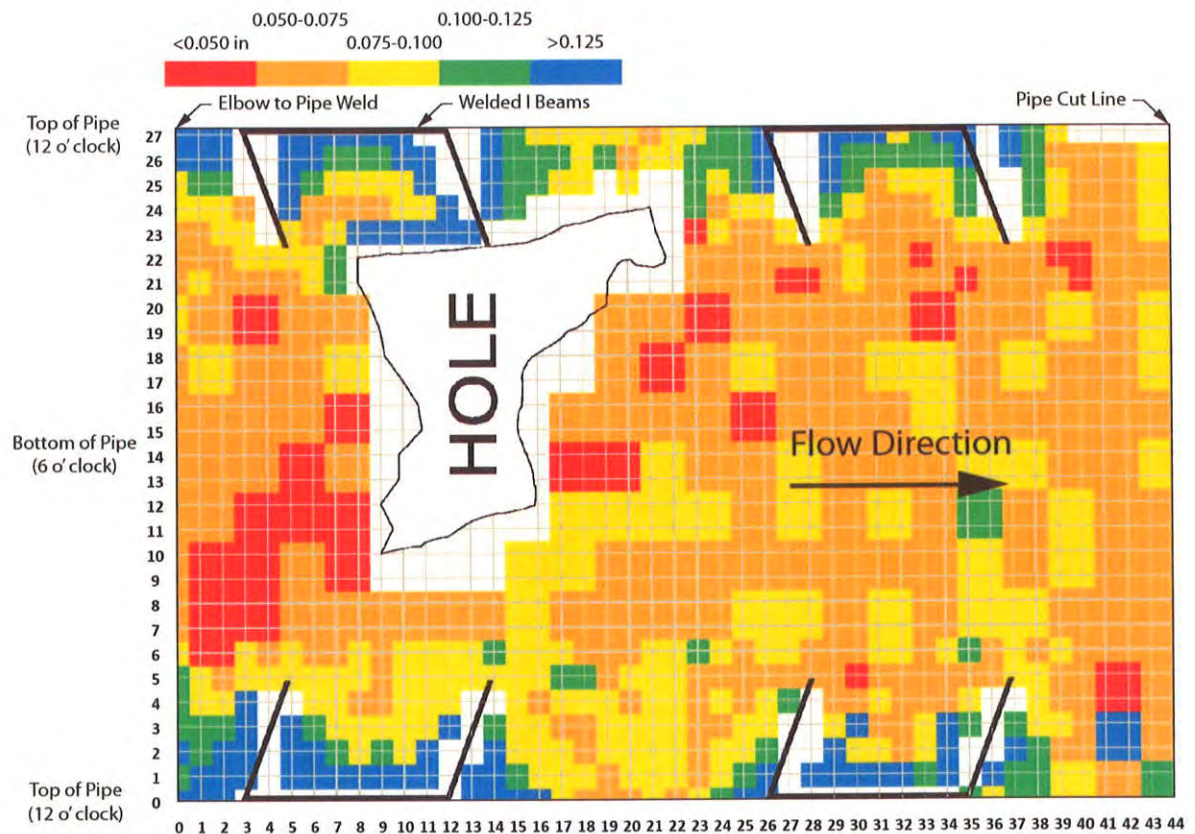
During the laboratory analysis at Anamet, thickness measurements were taken on the ruptured pipe component on a grid layout, as shown in Figure 9. Virtually the entire 27-inch circumference and 44-inch length of the ruptured pipe component had thinned to less than 0.10 inches, with only a few readings in the vicinity of the welded pipe guide attachments showing higher values.¹⁰ An ASME Code B31.3¹¹ analysis conducted by the Investigation Team determined that, in the area where the 4SC pipe ruptured, the minimum wall thickness required for containment is approximately 0.072 inches. The measured wall thicknesses of the ruptured pipe component were less than 0.072 inches (Figure 9).

Figure 9. Thickness measurement results from the ruptured pipe component. Virtually the entire 27-inch circumference and 44-inch length of the ruptured pipe component had thinned to less than 0.10 inches, consistent with sulfidation corrosion. The graphic represents the pipe as sliced longitudinally at the top of the pipe (12 o'clock) and rolled out flat. The areas in white could not be measured.

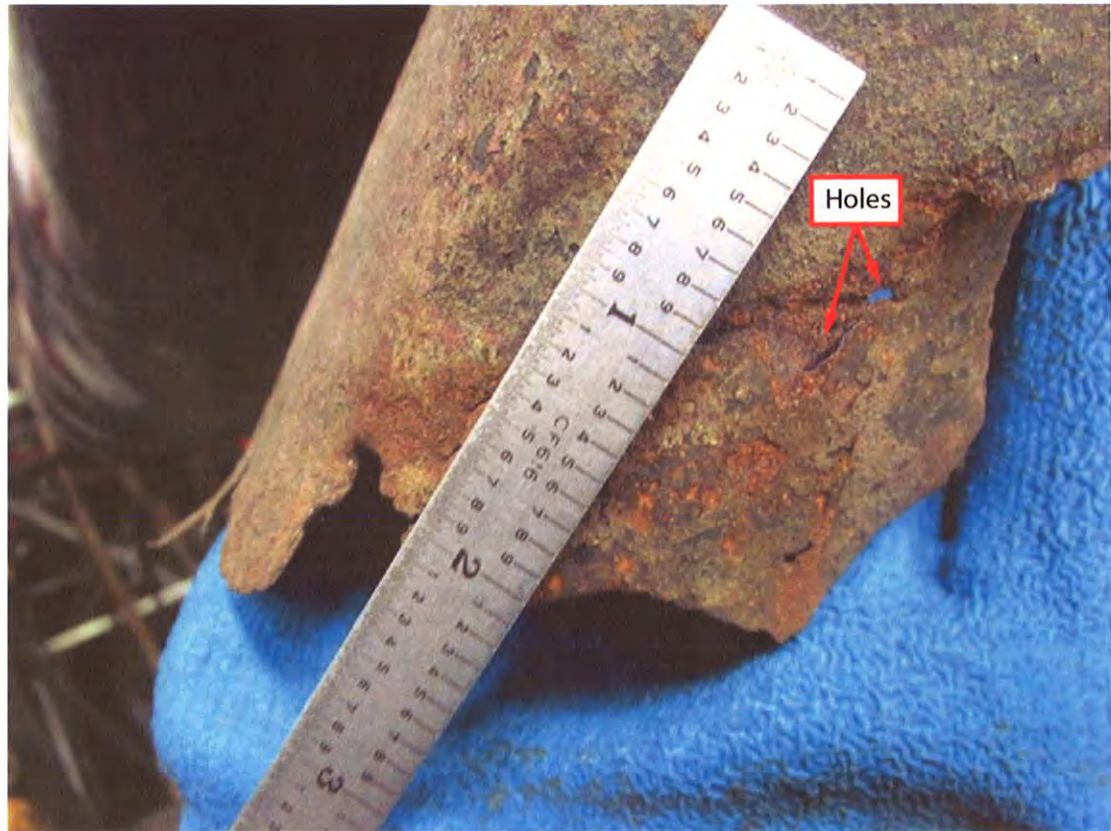
Figure 10. Photograph of one of the metal flaps associated with the 4SC rupture. Small perforations are visible in the flap.

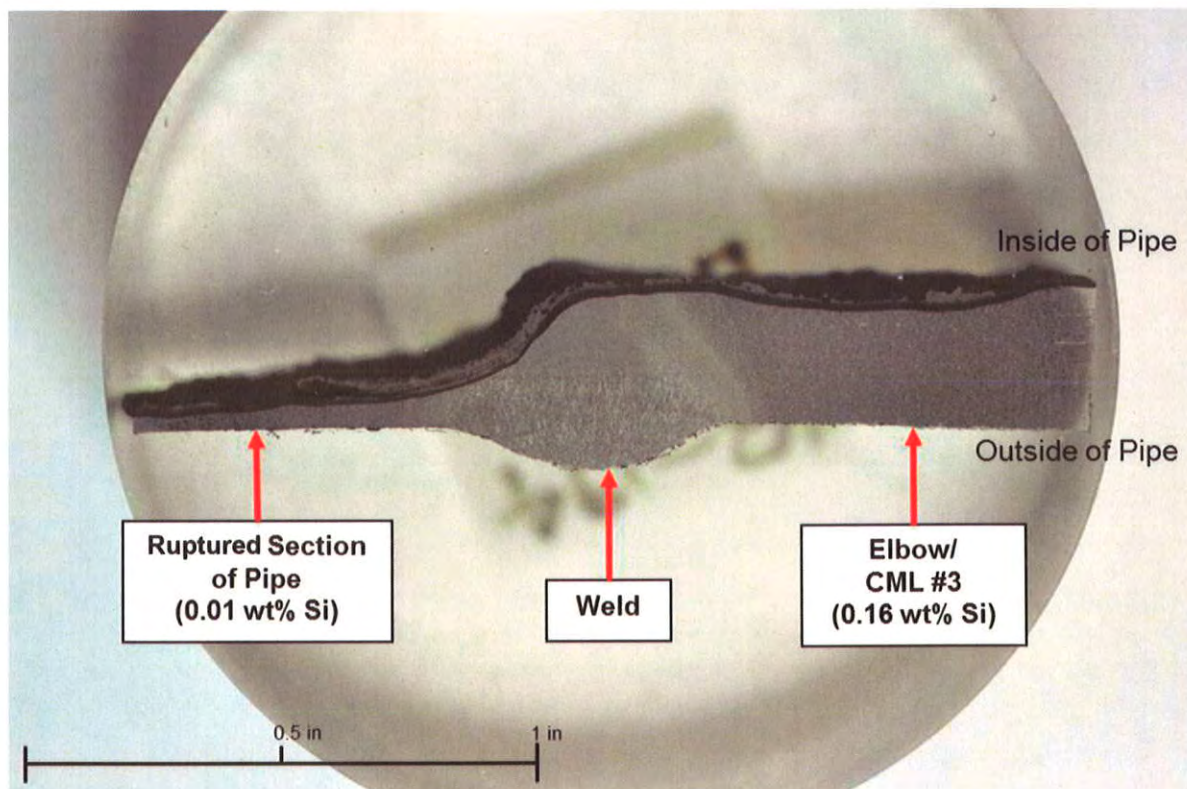
Figure 11 shows a cross section of the ruptured pipe, the adjacent elbow, and the weld between the two. Figure 12 shows the location where the sectioned sample was removed from the ruptured pipe. The ruptured component is clearly thinner than the adjacent elbow. The results of the chemical analysis indicate that the ruptured pipe component had a silicon content of approximately 0.01 wt% and the adjacent elbow had a silicon content of 0.16 wt%. As noted earlier, carbon steel with less than 0.10 wt% silicon content can exhibit higher sulfidation corrosion rates than carbon steel with higher levels of silicon. The impact of these differing corrosion rates is discussed in Section 4.

Figure 11. Cross section through the weld of the subject pipe showing thicknesses of the ruptured section (left) and the adjacent elbow, where CML #3 is located.

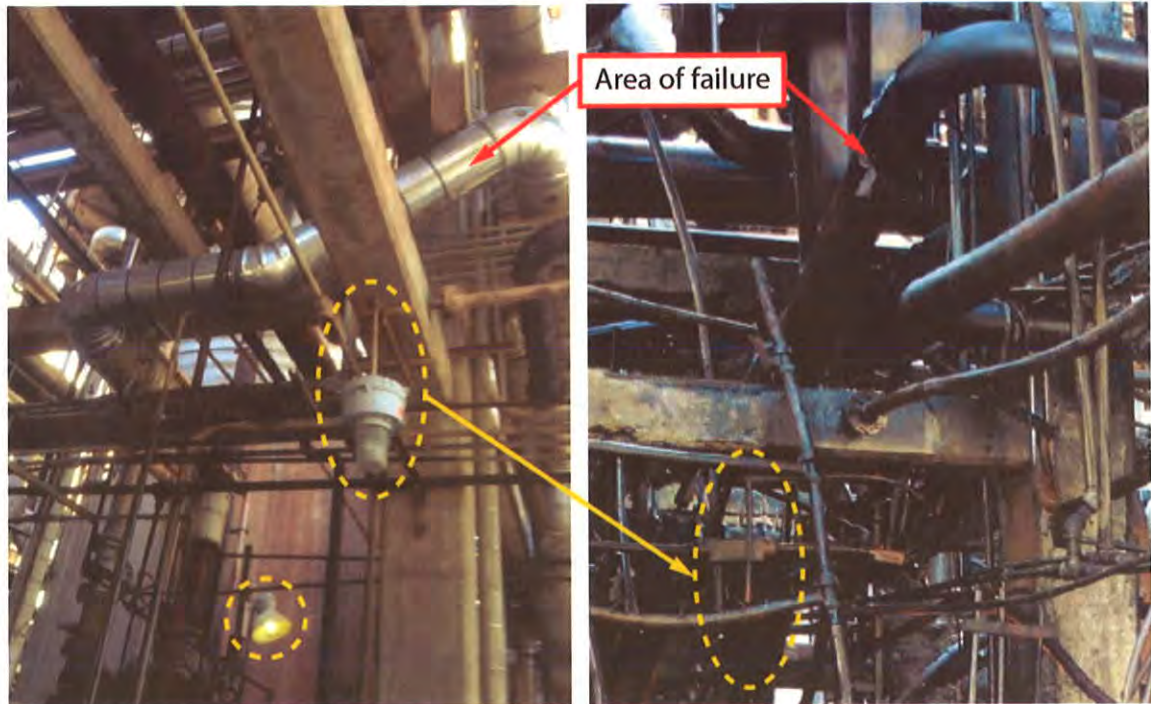
Figure 15. Lighting fixtures at the time the leak was discovered (photograph taken during the initial response) (left); and missing light after the Incident (right).

It is possible that the flow of hot liquid from the rupture location caused the lighting fixture to dislodge, exposing the wiring that provided power. After the white cloud formed and obscured the photo cell that controls the light, the lighting circuit may have energized. This photo cell was inspected and tested post-Incident. Testing showed that the photo cell activated at low light levels. With the circuit energized and wires exposed, this fixture could have provided an ignition source for the fire. This scenario also is possible if the bulb was burned out pre-Incident. Similarly, the photo shows the lower light fixture energized; this too could have provided an ignition source if the light fixture was dislodged by the flow of hot liquid.

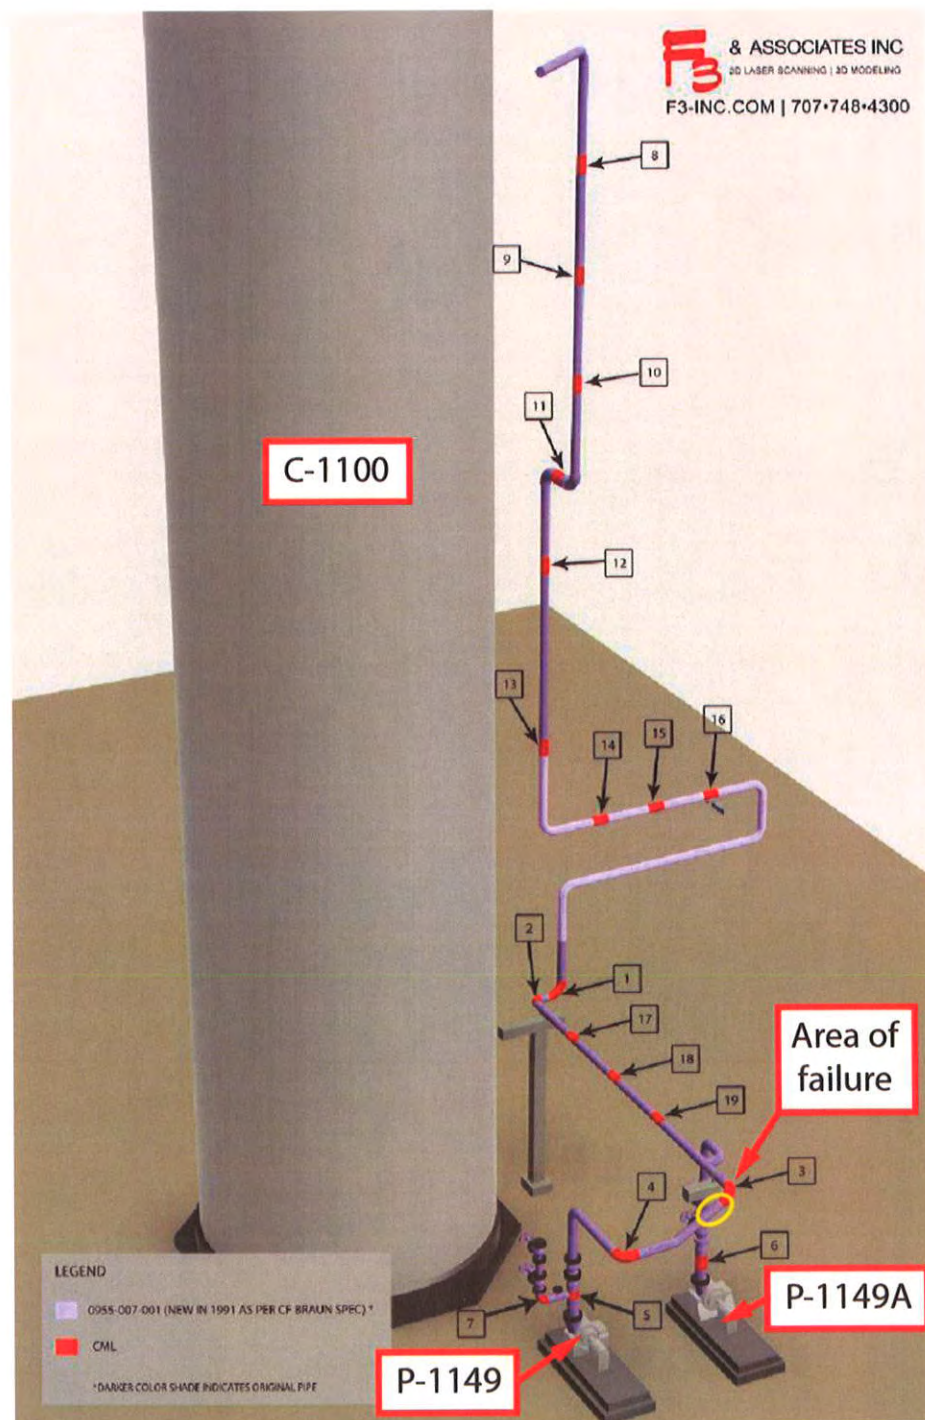
Figure 16. Three-dimensional model of the 8-inch 4SC line showing the CML locations. CMLs 1-6 were original, CML 7 was added in 2002, and CMLs 8-19 were added in 2011.

Inspection of the 4SC suction piping for P-1149/A included the seven historical CMLs (CML #1 through #7 shown in Figure 16) as well as the twelve new CMLs (CML #8 through #19). The new CMLs were chosen to include a variety of straight piping components supplementing the previous CMLs on fittings (elbows and tees). However, the 19 total CMLs did not cover all 67 components. None of the CMLs were on the failed piping component near CML #3.

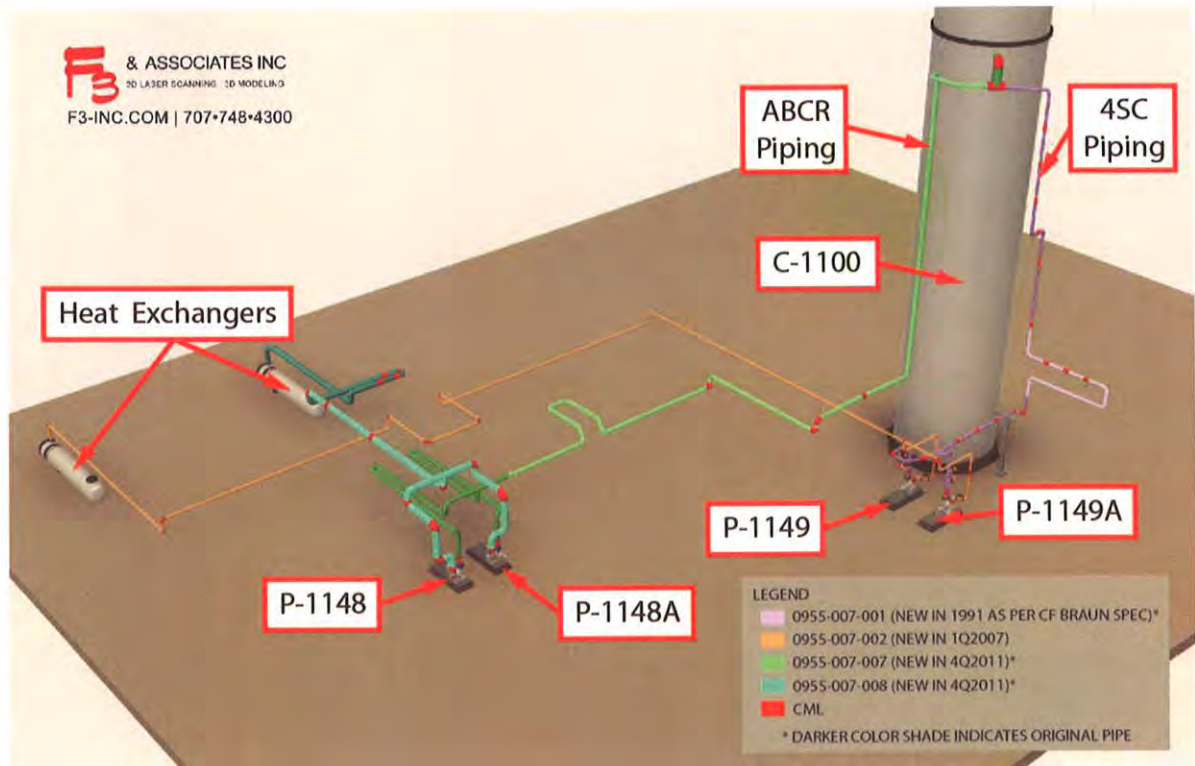
CML inspections of the ABCR piping showed wall thicknesses as low as 0.10 inches, indicating that the pipe could be too close to minimum thickness before the next Turnaround, scheduled for 2016, to leave it in service. Hence, portions of the ABCR piping were replaced with carbon steel piping during the 2011 Turnaround (see Figure 17).

Figure 17. Three-dimensional model showing the locations of the CMLs in the 4SC and the ABCR piping within the 4CU.
