**RE: Second 30-Day Update Report: January 29, 2017 Delta Energy Center Incident**

Subject: Delta Energy Center Oil Discharge – Emergency Response Final Report

# Delta Energy Center Oil Discharge – Emergency Response Final Report

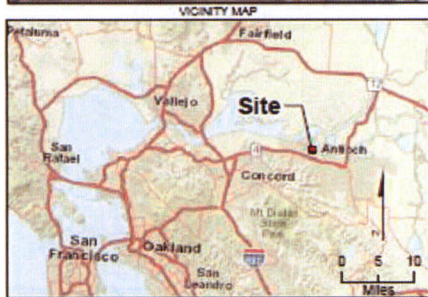
**FIGURE 1**  
**Site Figure**  
 Calpine Delta Energy Center Oil Discharge -  
 Emergency Response Closeout  
 Calpine Delta Energy Center, Pittsburg, California

- On January 29, 2017, Contra Costa Hazardous Materials Division responded to the incident, and assisted Delta Energy Center in deploying booms and pig mats in the outfall area and downstream of the outfall at Location C on Figure 1. The pig mats and absorbent booms were inspected every 2 hours and replaced with new booms, as appropriate, as they absorbed the oil.

- On January 31, 2017, oil absorbent floating booms were installed at the stormwater drain outfall to waters connected to Dowest Slough (Figure 1, Location A), the access road crossing south of the stormwater drain outfall (Figure 1, Location B), the Burlington Northern Santa Fe (BNSF) bridge crossing at the margins of the BNSF right-of-way (Figure 1 Location C), the culverts at East 5th Street (Figure 1, Location D), and the bridge at East 3rd Street (Figure 1, Location E). A vacuum truck was also deployed to the stormwater drain outfall to remove as much residual oil from the subsurface drainage system as possible. A summary of initial site observations, emergency response activities, and recommendations was presented in the *Calpine Delta Energy Center Oil Discharge - Site Observations and Response Recommendations* dated January 31, 2017. In addition, a permit application was submitted to USACE and the Water Board for the General Permit.

- On February 8, 2017, CDFW requested that an underflow dam be installed at Location C (Figure 1) to reduce potential migration of oil beyond the BNSF bridge crossing that could be caused by forecasted heavy rains.
