Re: 30-day Report for 8/13/16 Incident (Flaring)

1.0 Summary of Event

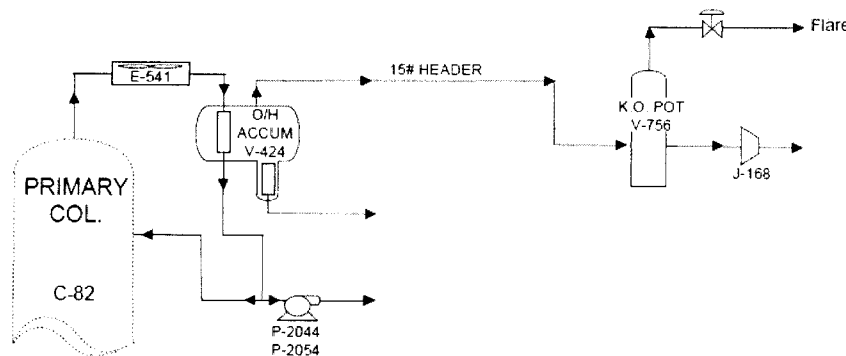
Process Flow Diagram (PFD)

The primary column (C-82) separates gasoline to diesel range hydrocarbons. The column overhead accumulator (V-424) stabilizes the column overhead liquid product by allowing vent gases to evolve to the 15# header before the liquid is pumped by overhead pumps P-2044 or P-2054 to a downstream process unit. The vent gas from the overhead accumulator is routed by the 15# header to the vent gas compressor knock-out pot (V-756) prior to being compressed through the vent gas compressor (J-168). The vent gas compressor has a controlled protective function to trip on high knock-out pot level to prevent liquid from going to the compressor. See process flow diagram below for details.

At approximately 12:21 pm J-168 tripped on a controlled protective function due to high liquid level in V-756. The increasing liquid level in the knock-out pot was caused by an overflow from the upstream overhead accumulator, V-424. The level in V-424 began to increase when overhead pump P-2054 tripped unexpectedly. At the time of the pump trip, the spare overhead pump (P-2044) was drained and blocked in due to a potential fugitive emission leak on a fitting of the seal flush tubing. After it was determined that the spare pump (P-2044) was safe to re-start, Operations started pump P-2044 and levels returned to normal.
