RE: Seventh Update to the 30-Day Report for the CWS Level 3 Event of August 6, 2012

Event Title: Richmond Refinery 4 Crude Unit Leak and Fire

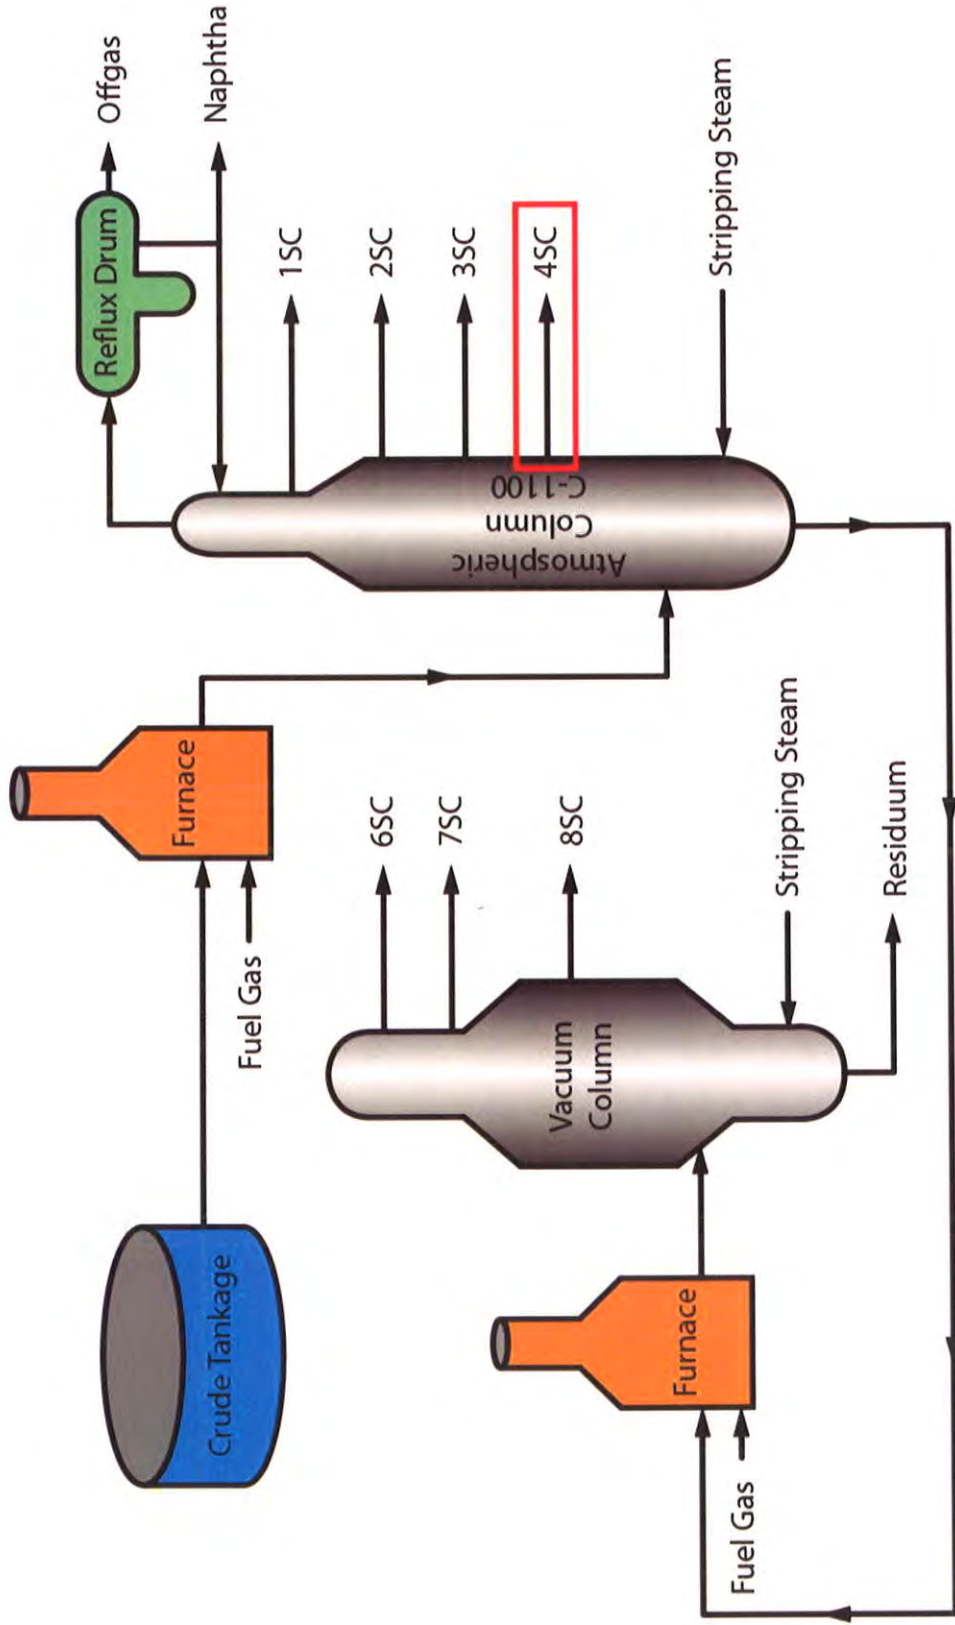
1100), which is fed with heated crude oil; and (2) the Vacuum Column, which is fed with the heated bottoms stream from the C-1100. Figure 2 shows a simplified flow diagram for the 4CU.

Figure 2. Simplified 4CU flow diagram. The failure occurred in the 4SC piping of the C-1100 (marked in red).

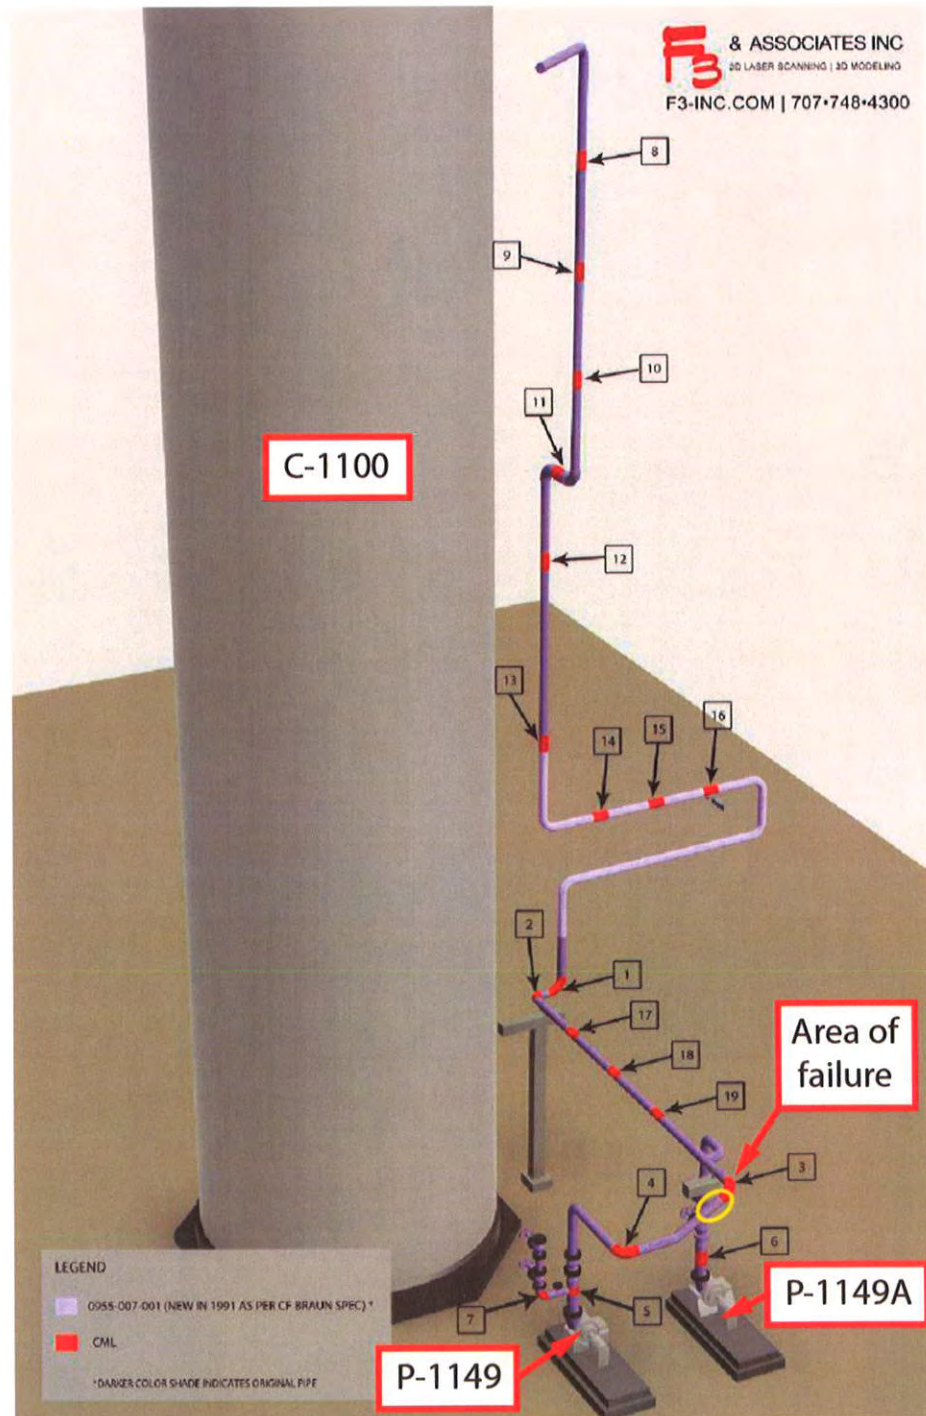
The 4SC inspection plan was to periodically measure thickness at CMLs considered representative of the piping circuit between the C-1100 and P-1149/A (see Appendix 2). The nearest CML to the failed pipe component was CML #3, which is located at the elbow directly upstream of the failure location, as shown in Figure 16.

Figure 16. Three-dimensional model of the 8-inch 4SC line showing the CML locations. CMLs 1-6 were original, CML 7 was added in 2002, and CMLs 8-19 were added in 2011.

Inspection of the 4SC suction piping for P-1149/A included the seven historical CMLs (CML #1 through #7 shown in Figure 16) as well as the twelve new CMLs (CML #8 through #19). The new CMLs were chosen to include a variety of straight piping components supplementing the previous CMLs on fittings (elbows and tees). However, the 19 total CMLs did not cover all 67 components. None of the CMLs were on the failed piping component near CML #3.

The small spool at CML #5 (shown in Figure 16) was recommended for replacement. When the Turnaround Core Team recognized that the spool could be replaced on-the-run during P-1149 maintenance, it asked Refinery Designs Engineering to calculate a minimum allowable wall thickness. The calculated 0.036 inches minimum thickness was based on simple hoop stress and deadweight stress calculations for the 8-inch pipe. Based on the estimated remaining life, the Core Team deferred replacing the washout spool. Although a Management of Change analysis was completed for this decision, other instructions in the Refinery Piping Inspection Guideline on completing Fitness for Service evaluations on pipe below Flag Thickness were not followed.

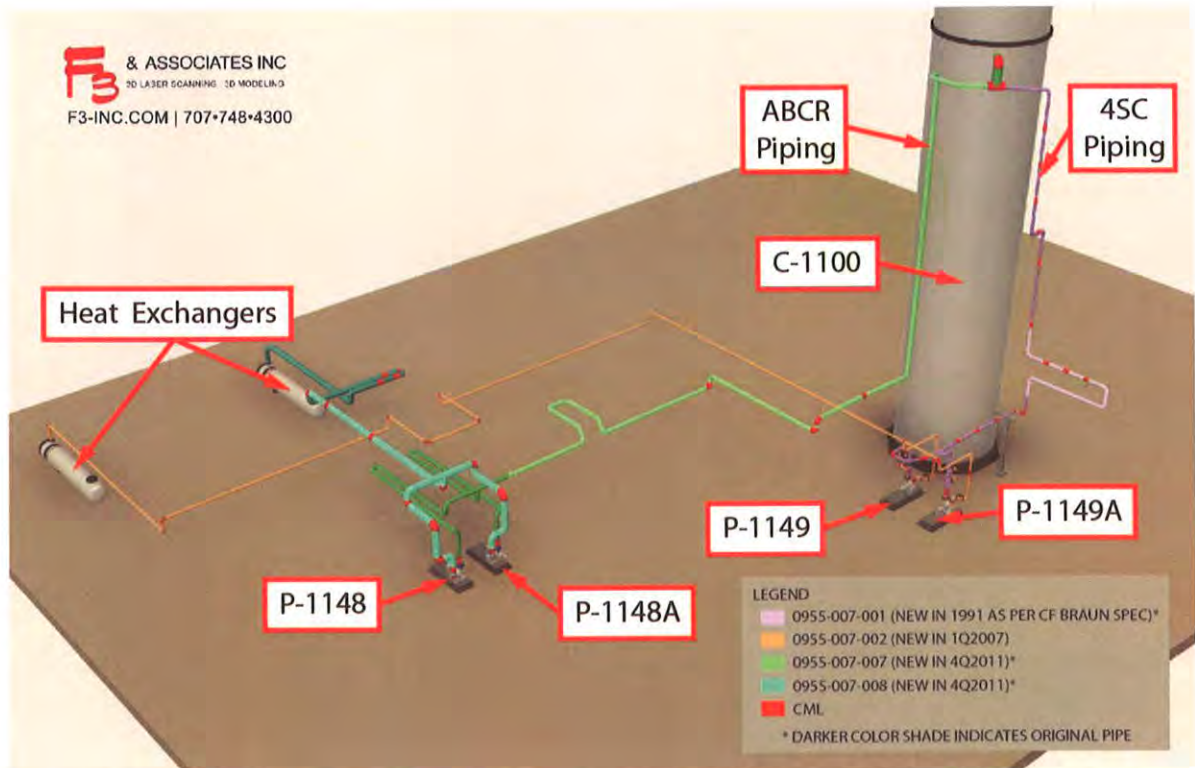
CML inspections of the ABCR piping showed wall thicknesses as low as 0.10 inches, indicating that the pipe could be too close to minimum thickness before the next Turnaround, scheduled for 2016, to leave it in service. Hence, portions of the ABCR piping were replaced with carbon steel piping during the 2011 Turnaround (see Figure 17).

Figure 17. Three-dimensional model showing the locations of the CMLs in the 4SC and the ABCR piping within the 4CU.
