RE: Seventh Update to the 30-Day Report for the CWS Level 3 Event of August 6, 2012

Event Title: Richmond Refinery 4 Crude Unit Leak and Fire

1. Introduction

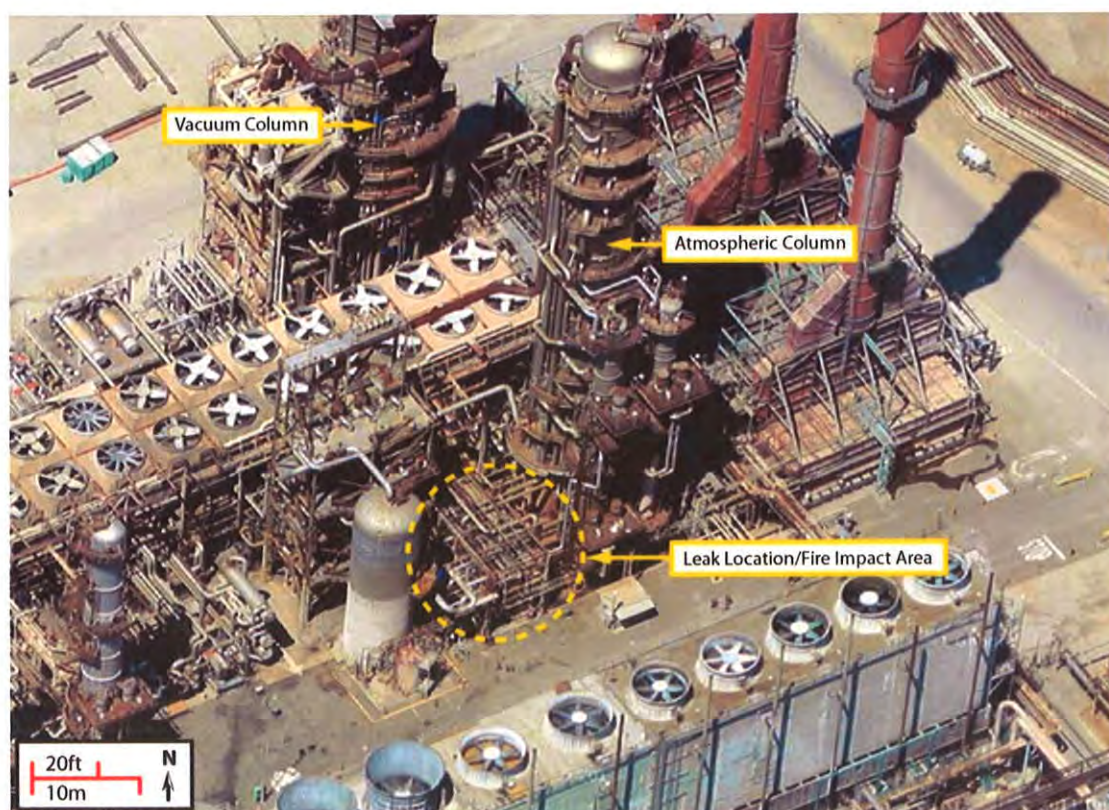
Figure 1. Overhead view of the 4CU prior to the Incident with the location of the rupture circled in yellow (image from Google Maps®).

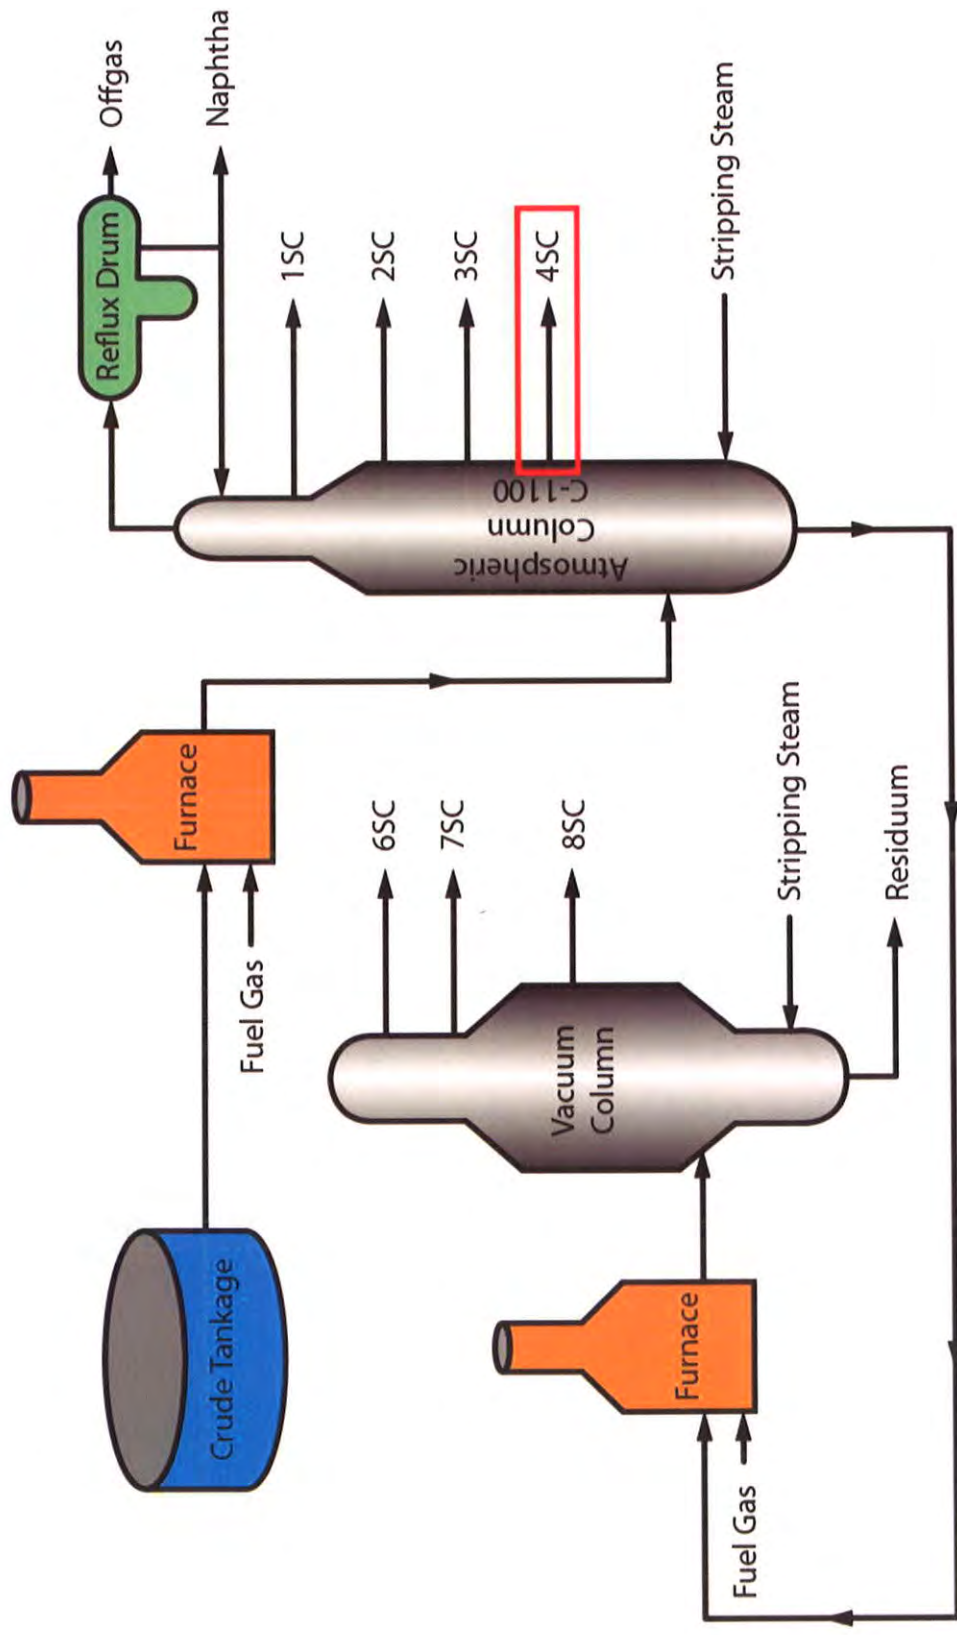
Figure 2. Simplified 4CU flow diagram. The failure occurred in the 4SC piping of the C-1100 (marked in red).

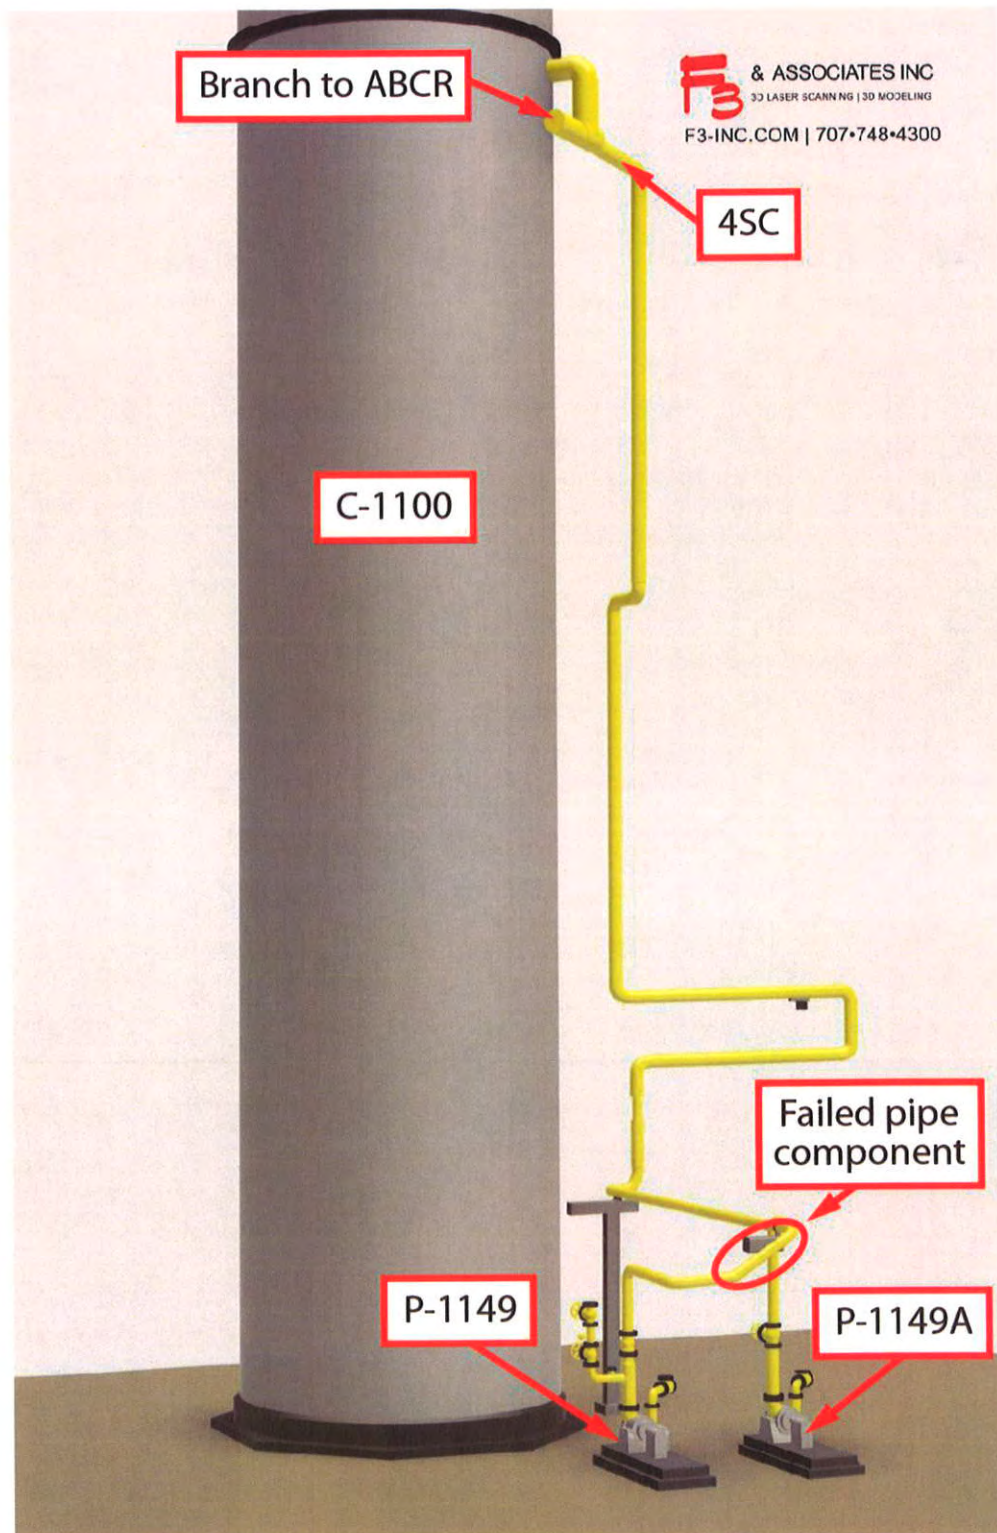
The 4SC and the Atmospheric Bottom Circulating Reflux (ABCR) are drawn via a 20-inch nozzle from the C-1100 (Figure 3). The piping branches to a 12-inch ABCR pipe and a separate 8-inch 4SC pipe. Post-Incident inspection showed that there were 67 components, including straight pipe and fittings (elbows, tees, flanges, etc.) in the 4SC piping between the piping branch and the 4SC stripper pumps.

Figure 3. Three-dimensional model showing the 4SC and the ABCR drawn via a 20-inch nozzle from the C-1100. Note: the ABCR piping is not shown beyond the initial branch.

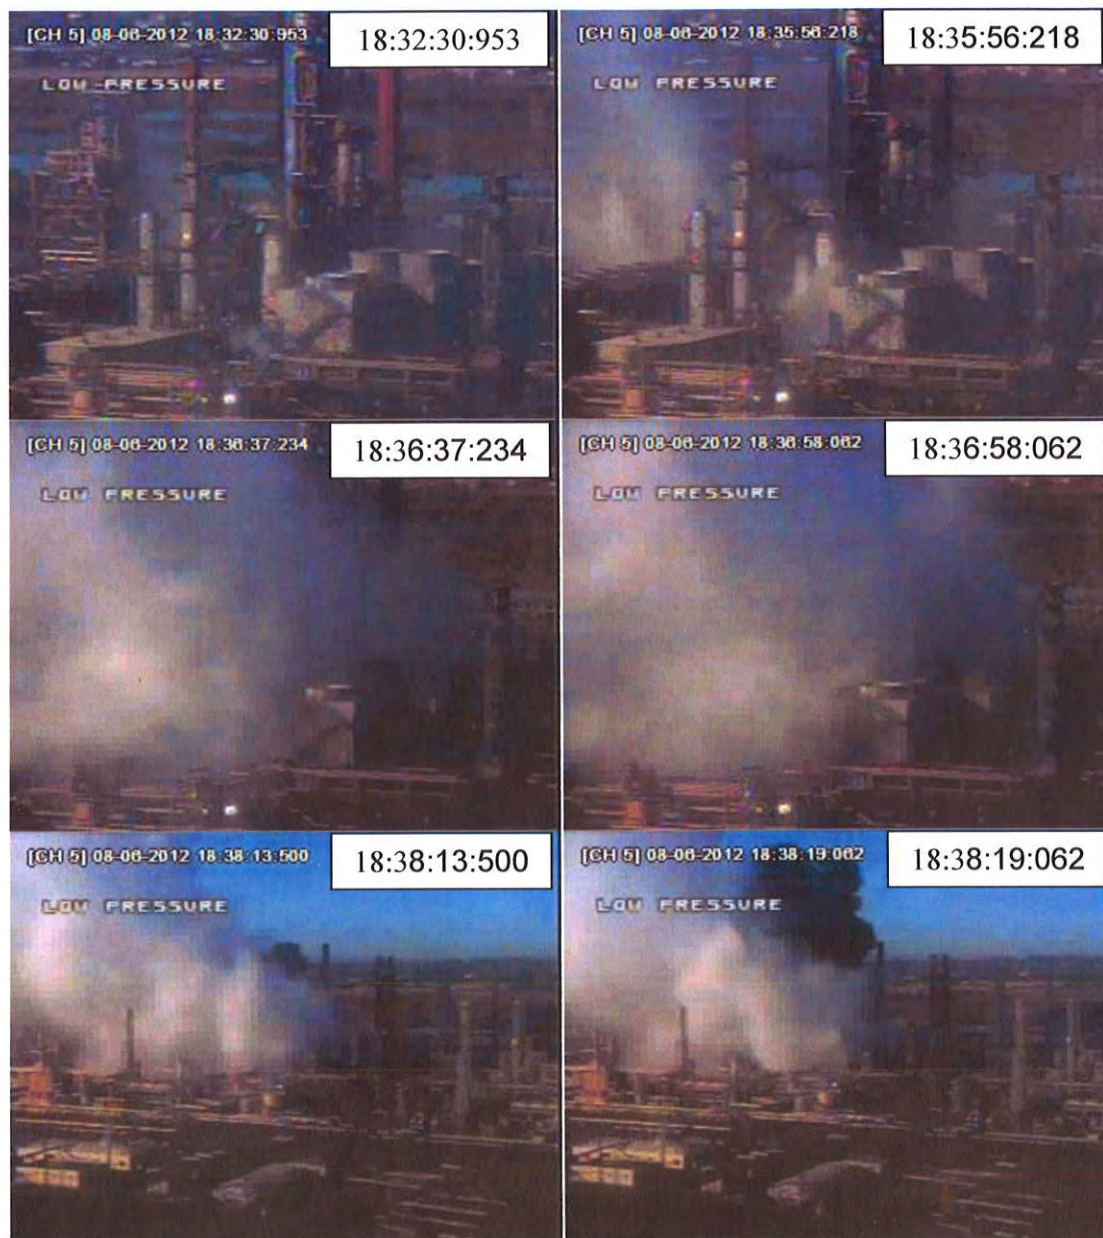
At approximately 1830 hours, the leak rapidly worsened, as confirmed by a radio transmission and video footage (Figure 6). As a result, a large white cloud formed and quickly enveloped the 4CU and downwind processing plants. Consequently, the CFD hose teams shut off the hose nozzles and withdrew from the area. Water application via the portable Blitz monitor continued and water flow from Engine Foam 60’s deck monitor was activated and directed toward the general area of the leak.

A fire ignited approximately 2 minutes and 30 seconds after the leak escalated, resulting in the formation of a black smoke plume⁸ (Figure 6: bottom). Multiple personnel told the Investigation Team that they saw flames originating near the location of the ruptured pipe component. At the time the fire ignited, the weather conditions were clear, with the temperature recorded at 75°F and 11.5 mph winds coming out of the southeast (134°).

Figure 6. CUSA surveillance camera showing the 4CU (top left). A white cloud is shown forming (top-right and middle-right/left) for approximately 2 minutes and 30 seconds after the leak escalated and before the fire ignited (bottom, camera had been zoomed out). (The clock in these images is approximately 5-7 minutes ahead of actual time.)

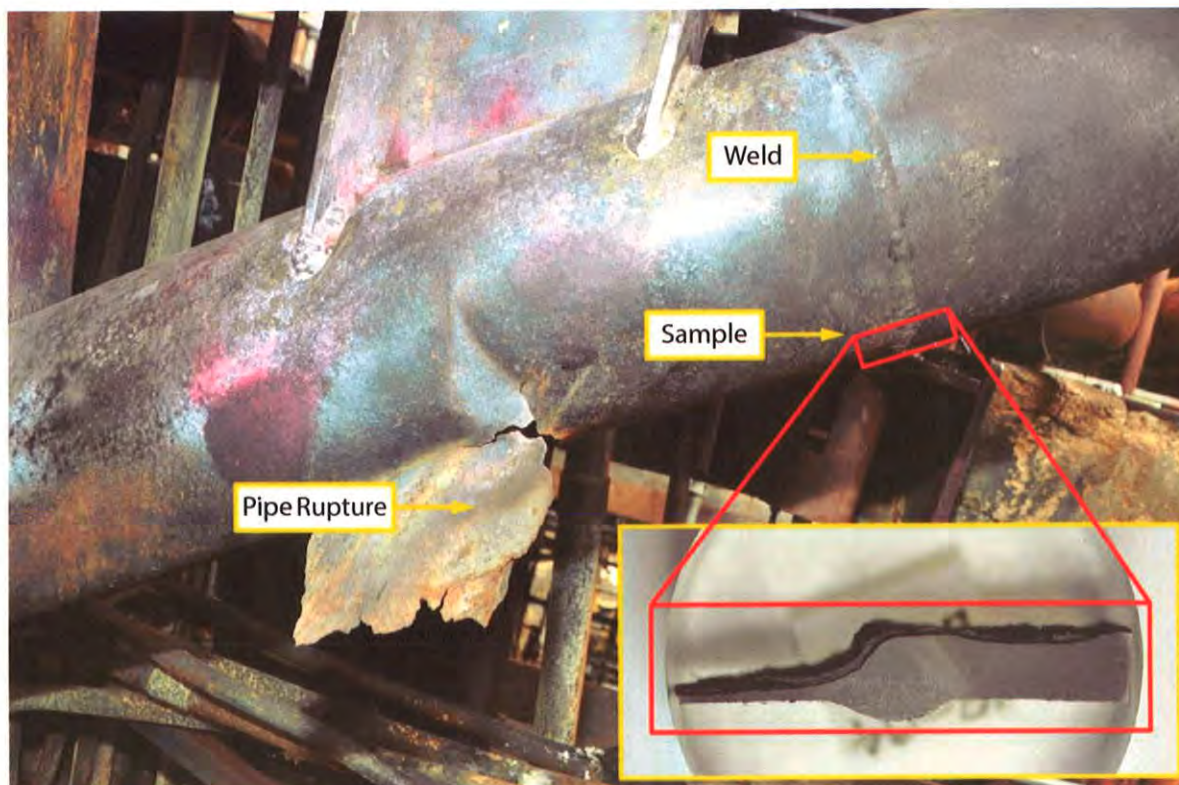
Figure 11 shows a cross section of the ruptured pipe, the adjacent elbow, and the weld between the two. Figure 12 shows the location where the sectioned sample was removed from the ruptured pipe. The ruptured component is clearly thinner than the adjacent elbow. The results of the chemical analysis indicate that the ruptured pipe component had a silicon content of approximately 0.01 wt% and the adjacent elbow had a silicon content of 0.16 wt%. As noted earlier, carbon steel with less than 0.10 wt% silicon content can exhibit higher sulfidation corrosion rates than carbon steel with higher levels of silicon. The impact of these differing corrosion rates is discussed in Section 4.

Figure 12. Image showing the location where the sectioned sample was removed from the ruptured pipe component.

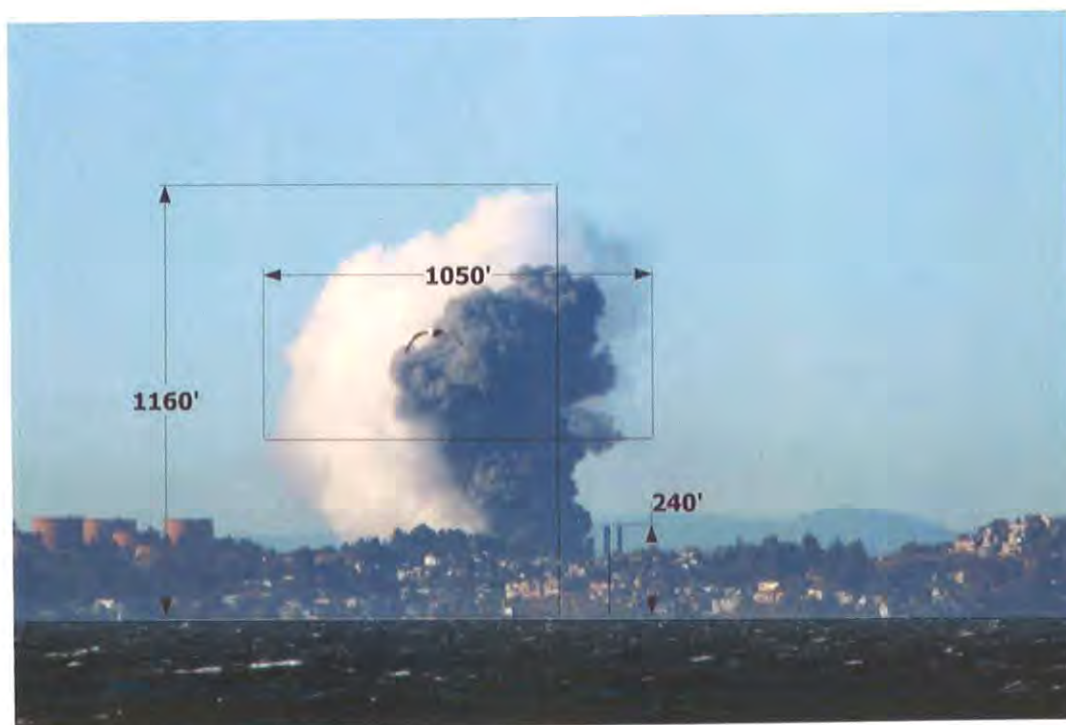
Just after ignition, a freelance photographer at Pier 39 in San Francisco and video footage shot from Marine View Avenue in Point Richmond captured the white cloud. Analysis was performed to estimate the size of the white cloud at the time witnesses reported the fire started. The largest dimensions of the white cloud were approximately 1,100 feet wide (in the east-west direction) and approximately 1,200 feet high, as shown in Figure 13.

Figure 13. Estimated size of the white cloud utilizing a photograph taken at Pier 39 in San Francisco. The 240 foot dimension shows the height of the 4CU furnace stacks.

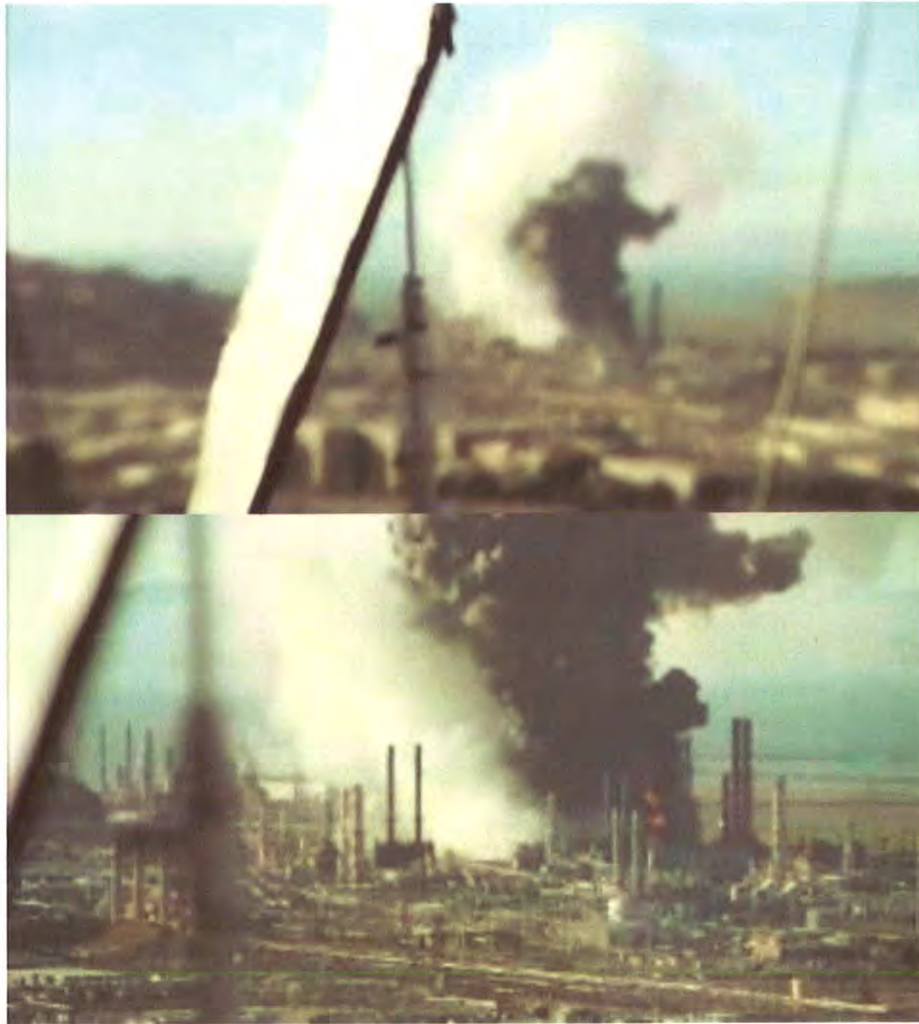
Incident site inspections, witness observations, and video footage show that the vast majority of the white cloud did not ignite. According to witnesses, ignition occurred near the pipe rupture, resulting in a black smoke plume. A clear demarcation was observed between the black smoke plume and the white cloud, as shown in Figure 14. Flames were visible in the video footage, providing a competent ignition source for the white cloud. However, the white cloud persisted for several minutes in the immediate vicinity of the black smoke plume even after the ignition. No flames were observed propagating through the white cloud and no signs of overpressure were observed.

Figure 14. Stills from video footage taken from Marine View Avenue in Point Richmond that shows the formation of the black plume shortly after ignition of the fire (top), and after continued burning (bottom).
